River Bränningeån: habitat improvement

River Erstaviksbäcken: fish pass and habitat improvement

River Vitsån: habitat improvement

River Skeboån: Habitat improvement and plans for fish pass

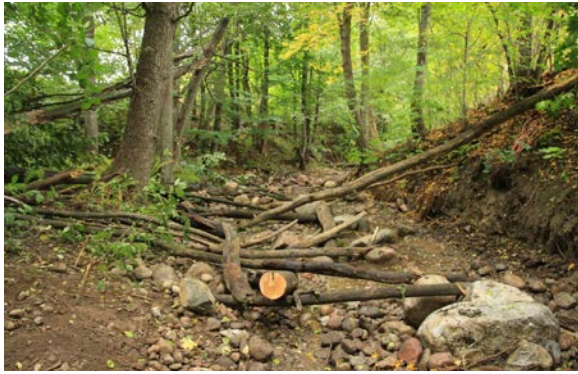
Figure 45. A mixture of gravel, larger stones and existing logs were placed on stretch 1 and 2. Photo credit: John Kärki.

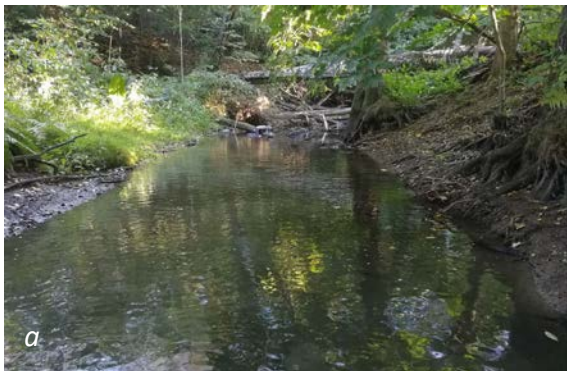
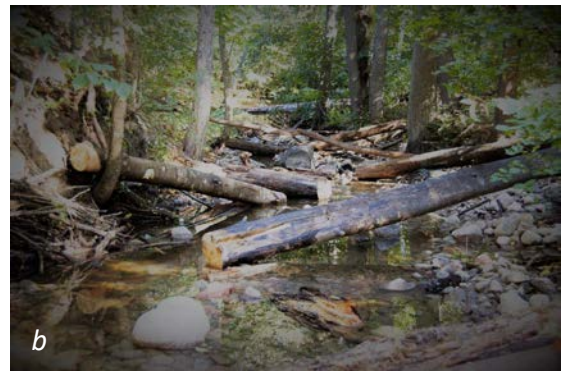
Figure 47. Stretch 1 before (a) and after (b) the activities. The cleared river stretch has been restored with stone and gravel bottom and plenty of large stone and logs. Photo credit: John Kärki.

A total of 280 tonnes of gravel and stone were added to the river during the restoration. Most of the material was placed on stretches 1 and 2. Adding large stones and gravel to the river created heterogeneity and structure (Figure 45). On stretches 1 and 2, logs were also placed into the watercourse to provide additional complexity (Figure 46). An estimated 50 meters were restored at stretch 1 and 80 meters at stretch 2. At stretch 3, about 18 tonnes of gravel were placed along a 35-metre stretch to create for spawning grounds for trout. This stretch consists of an old stone lined part of the river close to the old hydroelectric power construction. On the site two larger riffles were created, designed as spawning sites. Existing deep pools were preserved. In conclusion, the measures created a greater variation in the river with better conditions for sea trout and biodiversity (Figures 47 and 48).

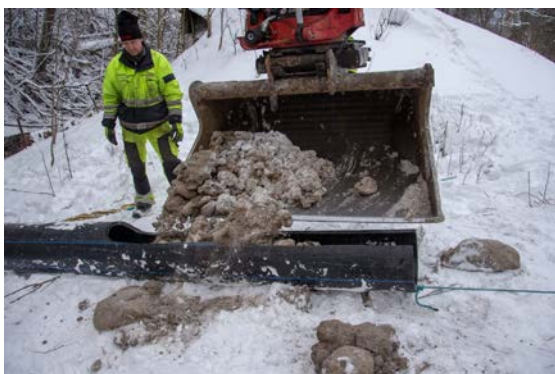
At stretch 3, the sensitive and soft ground conditions made it impossible to get close enough with the heavy excavator to distribute stones in the river. To solve the issue, a specially designed pipe was used to get the gravel into the watercourse (Figure 48 and 49). In this way, the excavator could stand on stable ground a short distance from the watercourse and still reach into the watercourse. The pipe could easily be moved to reach new parts of the watercourse.

Figure 48. The deployment of gravel on stretch 3 was carried out with an excavator and a specially adapted pipe. Photo credit: John Kärki.

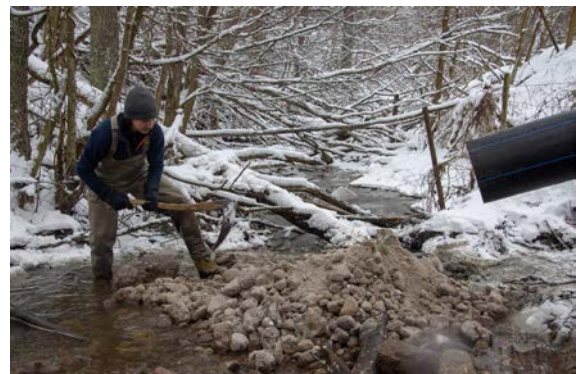
Figure 49. When the gravel had been added to the watercourse, it was distributed by hand. Photo credit: John Kärki.

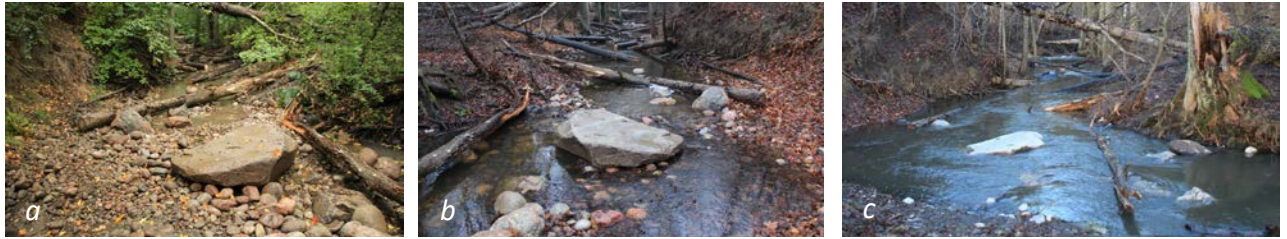
It is difficult to visualise the river at different levels of flow and how it will look like at e.g., high flow conditions if the work is carried out at low flow conditions. The watercourses can often swallow more material than originally thought. The restoration sessions in September were performed during low flow due to a dry summer and autumn (Figure 52). During implementation, one could easily be led to believe that too much material was placed in the watercourse. Once the autumn rains came and water flow increased, it was clear that not too much material had been used. It is important to design the restored structures so that they have the wanted features across the full spectrum of seasonal variations.

Figure 52 a-c. During autumn 2018, the water flow in Bränningeån was extremely low due to a very dry summer. Immediately after the restoration, stones and gravel were therefore very prominent (a). Picture taken from stretch 1 on September 26, 2018. It was not until late autumn that rainfall and water flow increased. The picture was taken from stretch 1 on December 3, 2018 (b). At higher water flow, the restoration gave a completely different impression. Only the larger stones were visible in the watercourse. The picture was taken from stretch 1 on December 10, 2018 (c). Photo credits: Anton Larsson.

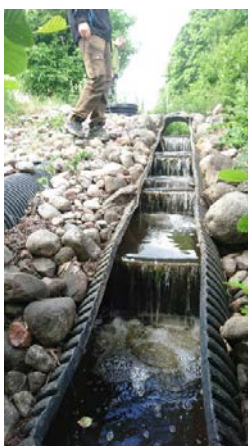
There are three man-made migration obstacles in the creek. The lowermost is a poorly functioning fish pass situated close to Ersta Manor, 200 m from the river mouth. In theory it is passable for sea trout, but in reality, only a few trout are found upstream, despite better spawning grounds.

a. The old fish pass. Migration obstacle at low flow conditions.

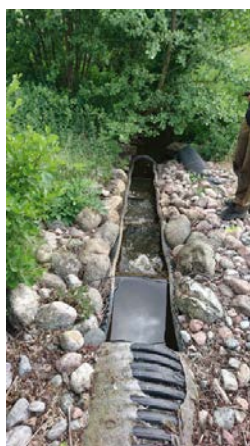
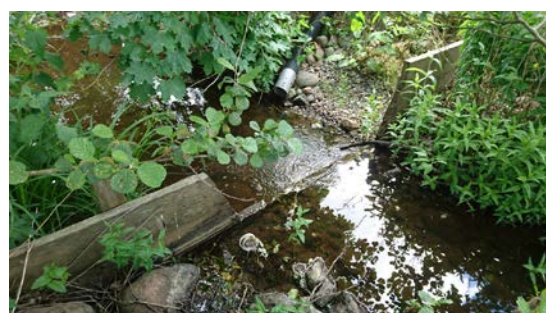
b. Wooden threshold downstream of the fish pass, Migration obstacle at low flow conditions.

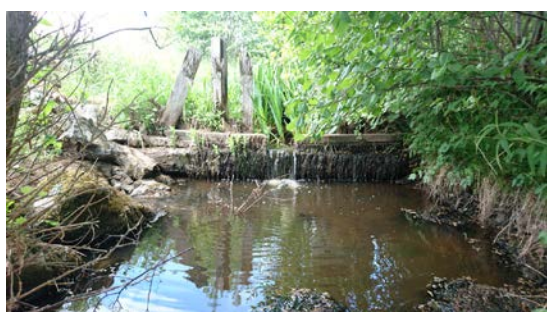
c. Wooden weir upstream the fish pass. Migration obstacle at low flow conditions

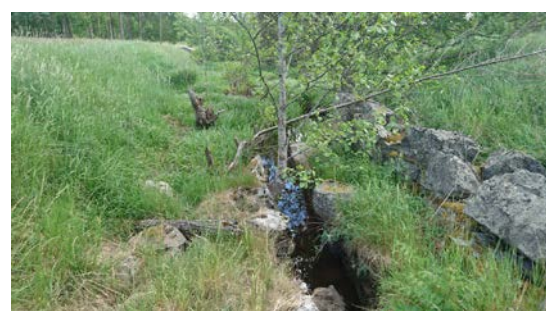
d. Remnants of an old water driven saw. Probably not a migration obstacle

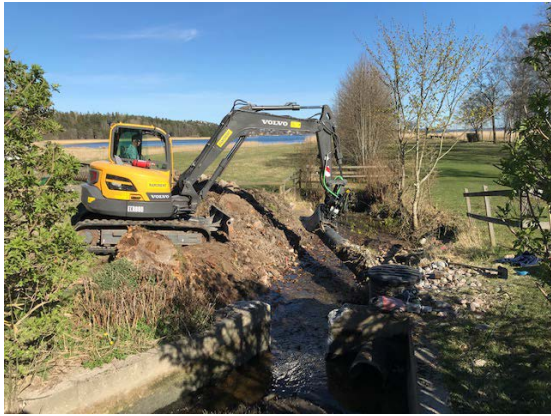
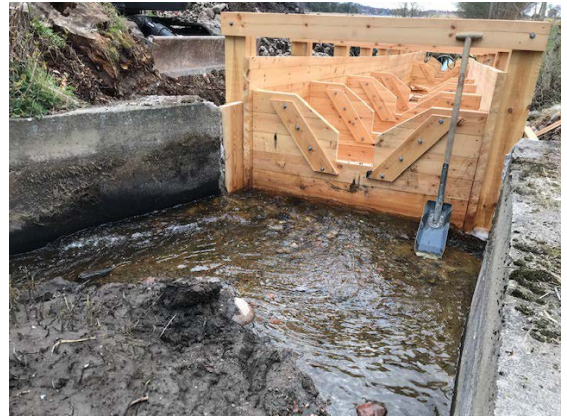
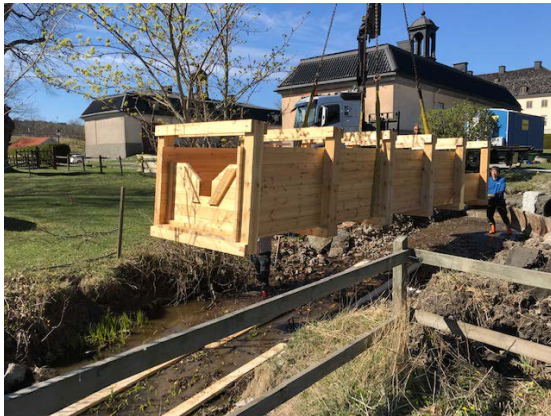
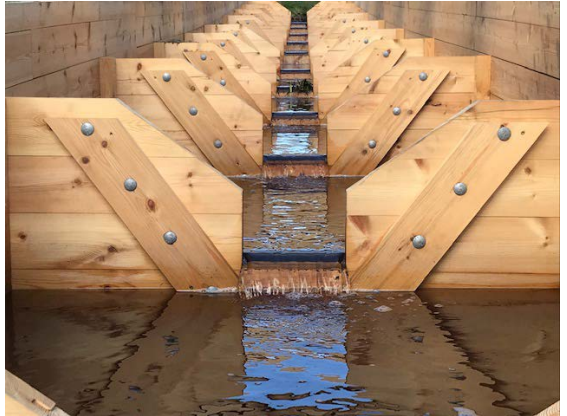
It took three days to remove the old fish pass and install the new one (Figure 59). The first attempt to install the fish pass did not succeed completely. There was water running besides the pass, which is not wanted. The builder had to return to seal the leak. Later that caused a disagreement about the bill, which could have been avoided had the contract been made clearer. The completed fish pass seems to work according to plan, but it is too early to judge now. The evaluation programme will later provide more information.

Figure 59. The old fish pass is removed (upper left) and the new one is installed. When the leak was sealed all pools was filled as planned (lower right). Photo: Oliver Karlöf.

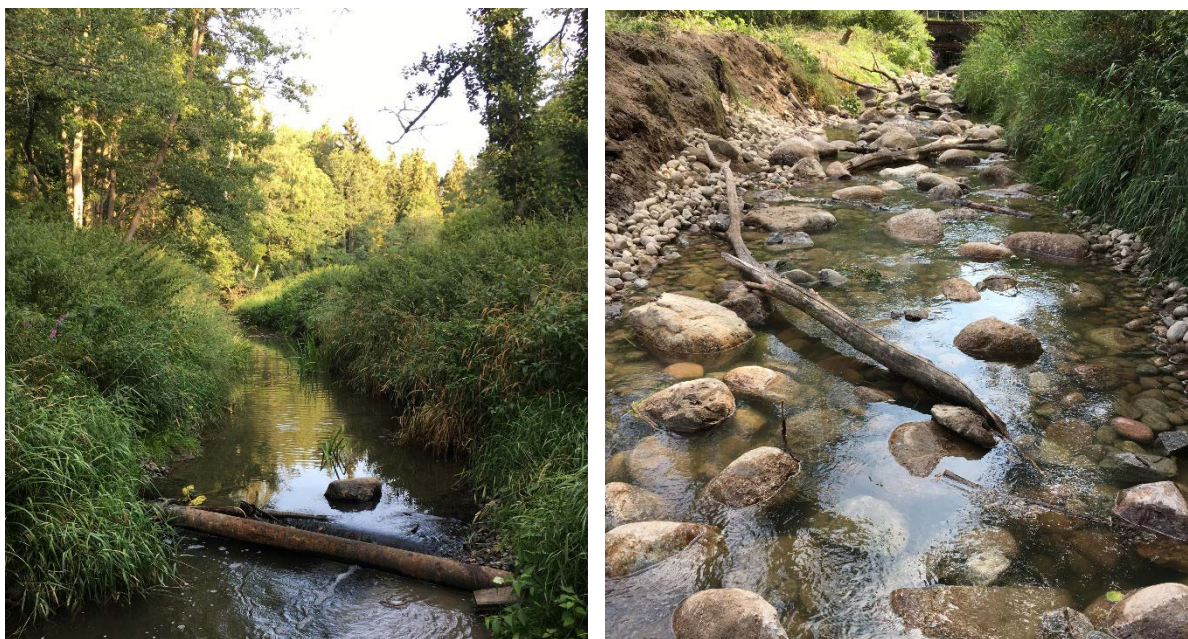
Figure 67. Vitså river upstream the old mill before (left) and after (right) the activities.

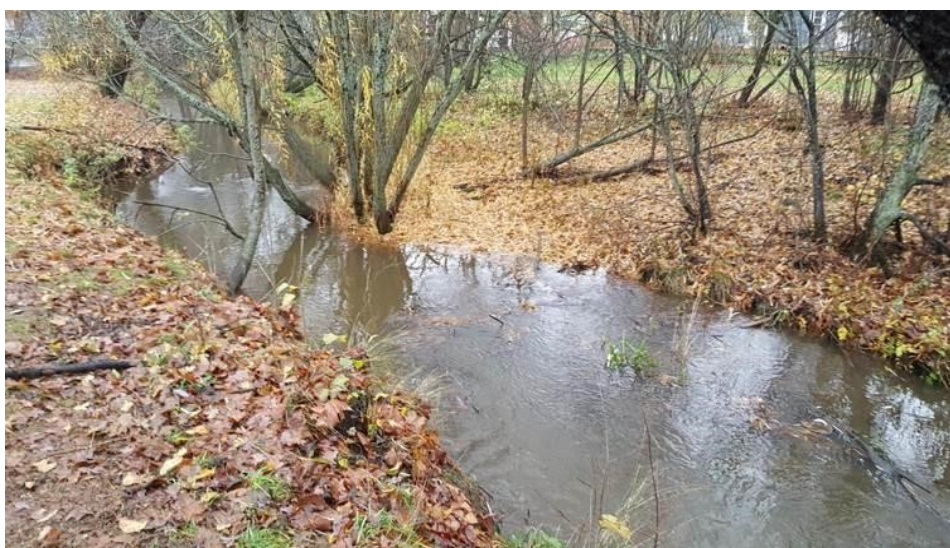
Figure 68. Site 6 in figure 6. Before activities October 2019.

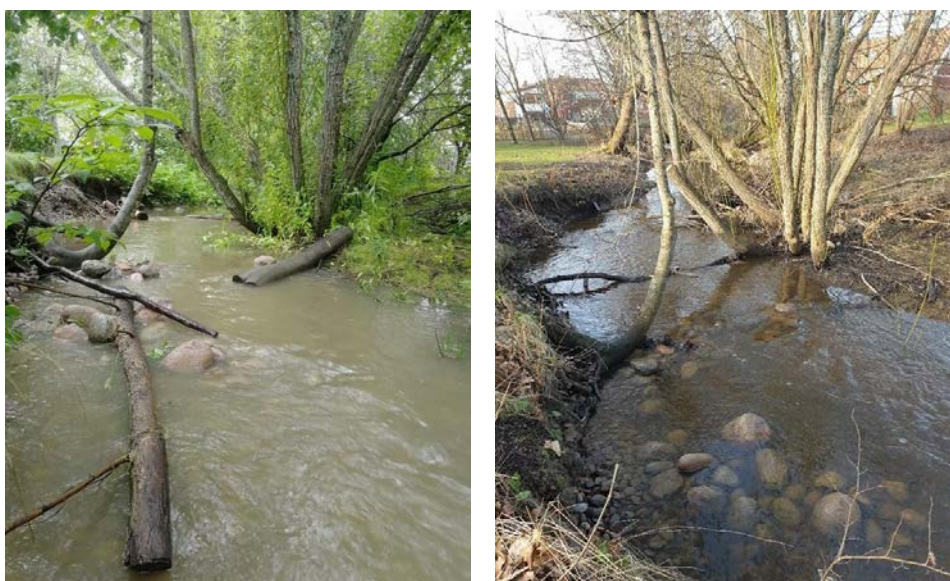
Figure 69. Site 6 after activities September 2019 (left) and January 2020 (right).

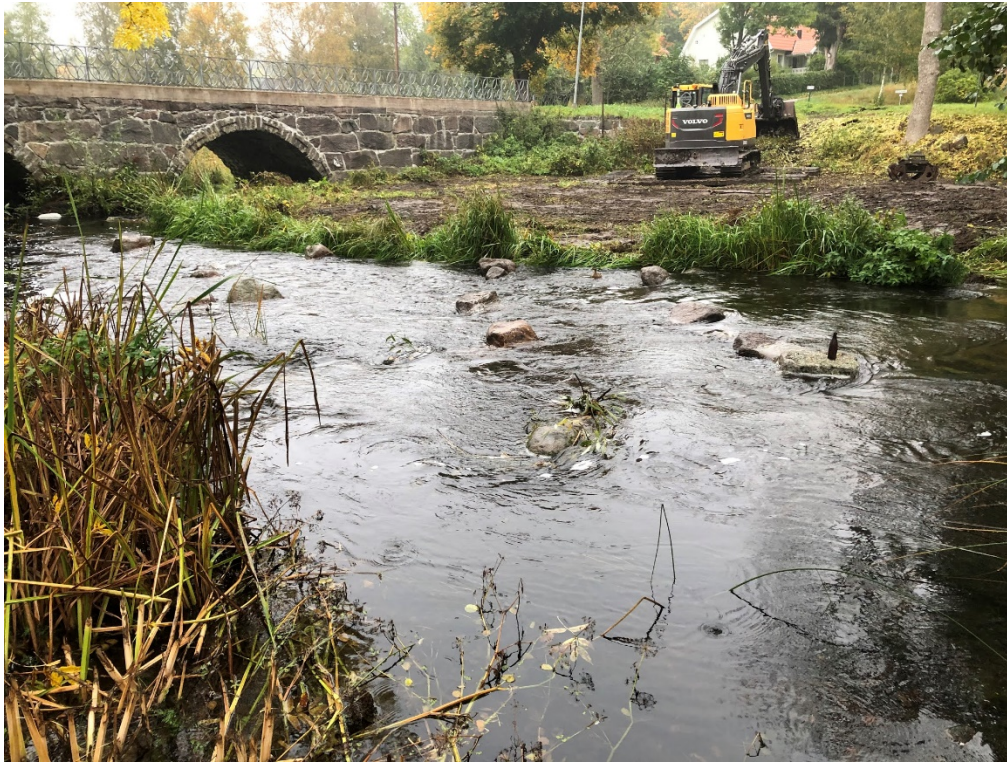
Figure 79. Stretch 1a, Skebobruk, during implementation. A multichannel stretch is recreated. Photo credit: Patrik Bergquist.

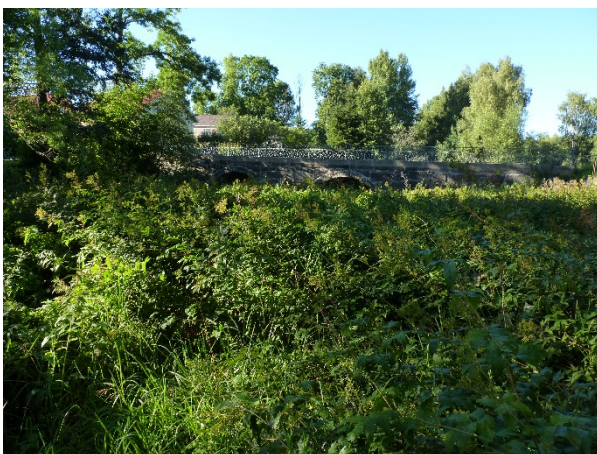
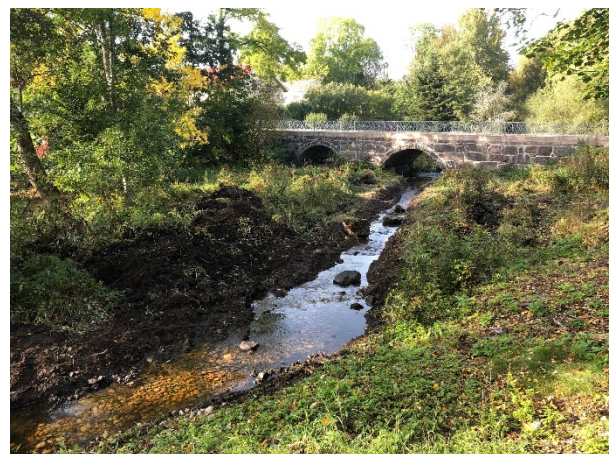
Figure 80. Stretch 1b, Skebobruk, before (left) and after (right), a new multichannel stretch. Photo credit: Patrik Bergquist.

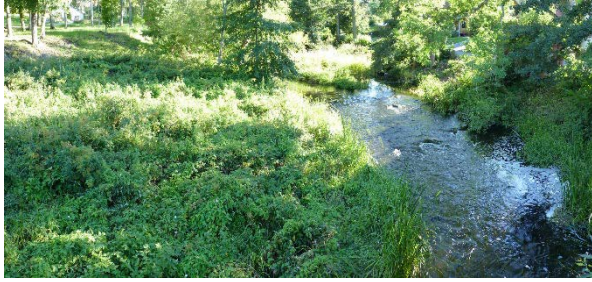
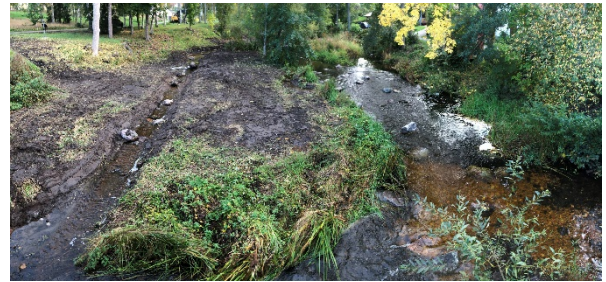
Figure 81. Stretch 1b, Skebobruk, before (left) and after (right), a new multichannel stretch. Picture taken from the bridge. Photo credit: Patrik Bergquist.

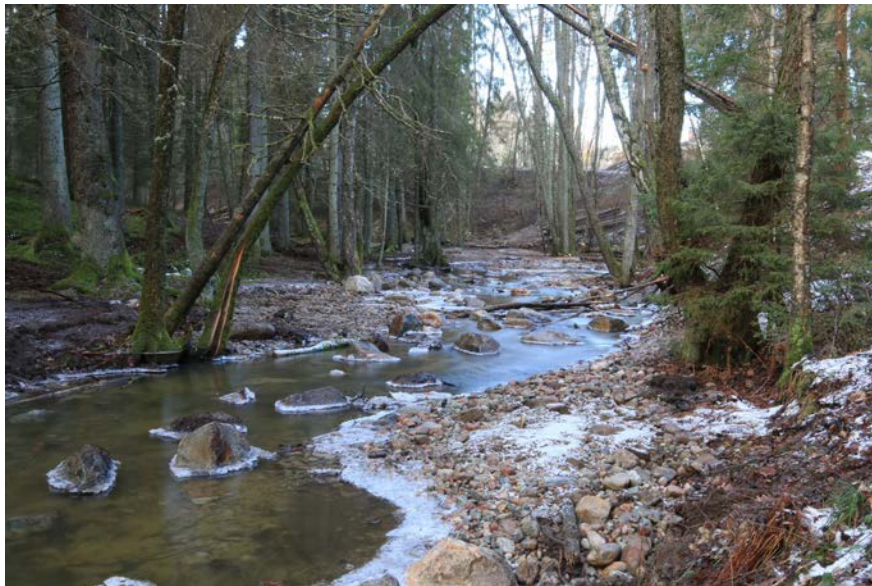
No electrofishing has been done yet, but are planned to be performed during 2021. Regarding the hydromorphological properties of the stretch, the restoration activities was a success. The previously cleared stretch has now a very fine and varied stream water environment with potentially high values for aquatic fauna, especially as a spawning and rearing environment for trout (Figure 94 and 95). It may however be considered a failure that the public opinion, at least in part, was negative to the activities since they had not been reached by information about it. It is not known if this negative opinion persists.

Figure 94. Work completed. Kallforsån 2019. Photo Tobias Fränstam

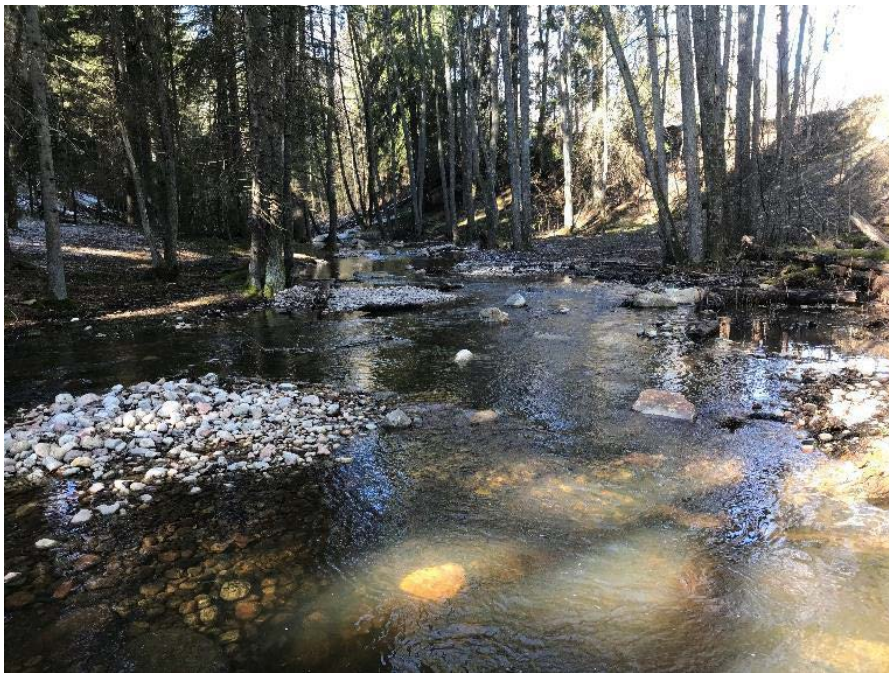
Figure 95. Work completed. Kallforsån 2019. Photo Tobias Fränstam

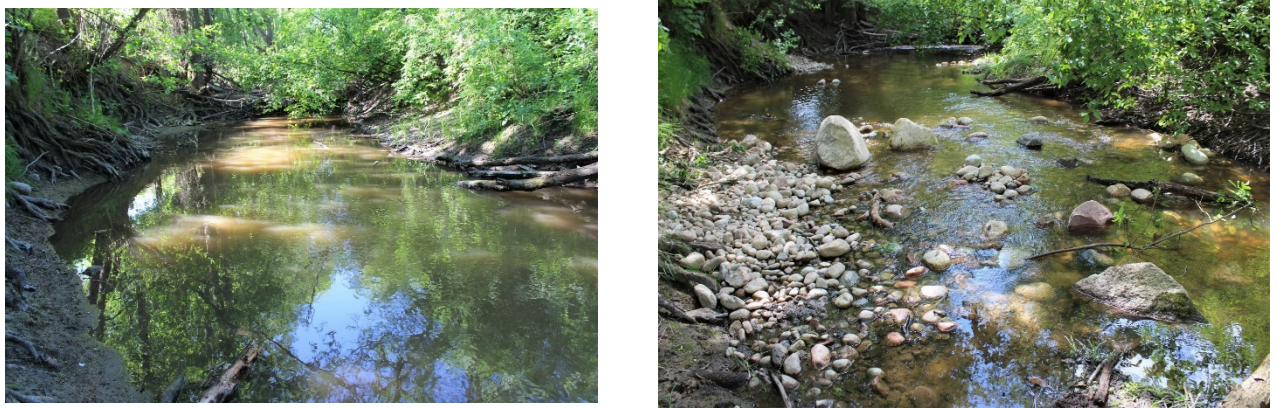
Figure 97. One site at Norrbyvälle before (left) and after (right) restoration measures. Photo: Mikael Lindén.
