# RETROUT River Restoration Demonstration Case Reports

## RETROUT project report

For bibliographic purposes this document should be cited as: "RETROUT 2021. RETROUT River Restoration Demonstration Case Reports. Interreg RETROUT project.

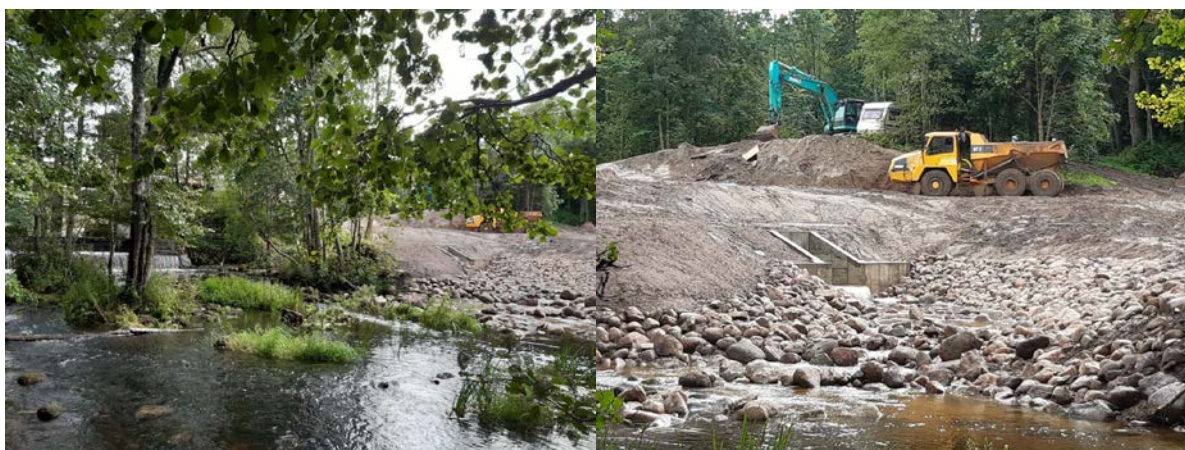
Figure 23. The fish pass site during construction in August 2020. Photo credit: Kaspars Abersons.

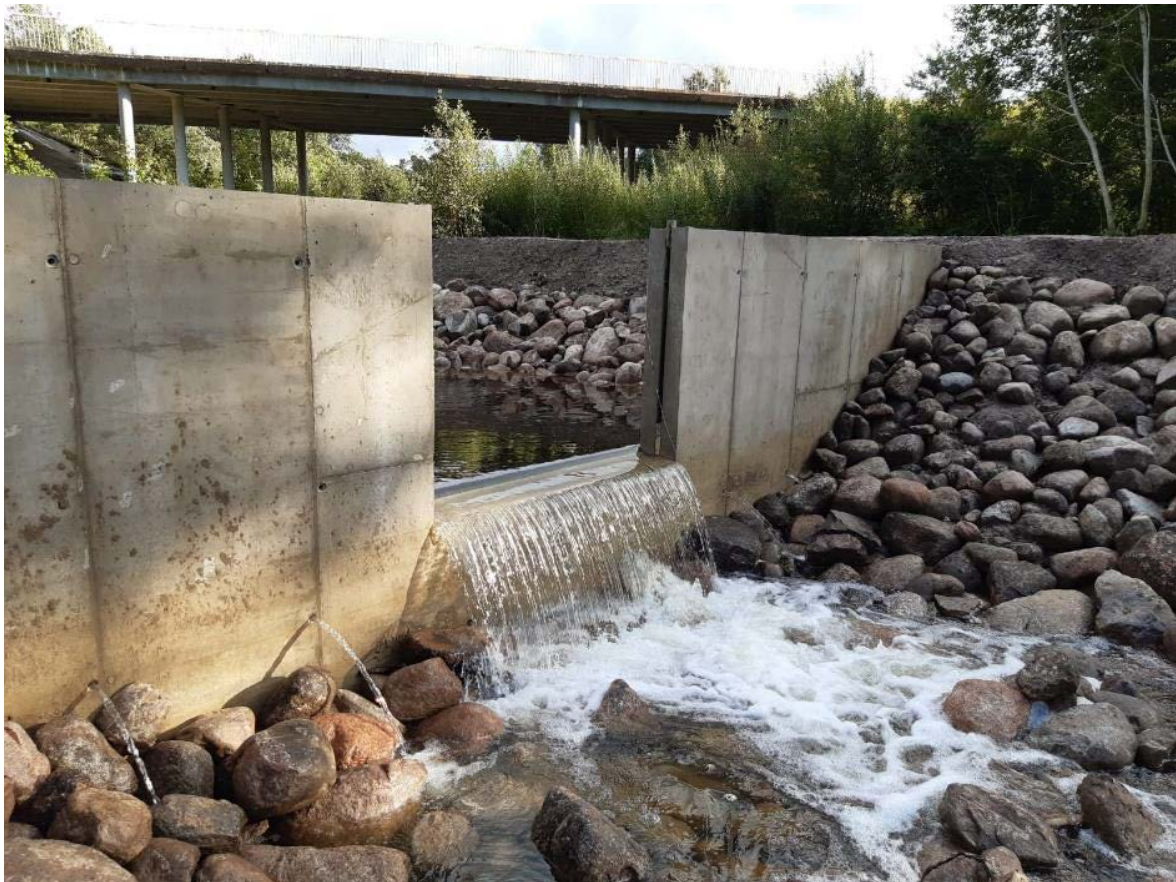
*Figure 24. The fish pass site after construction in September 2020 (Photo credit: Kaspars Abersons).*

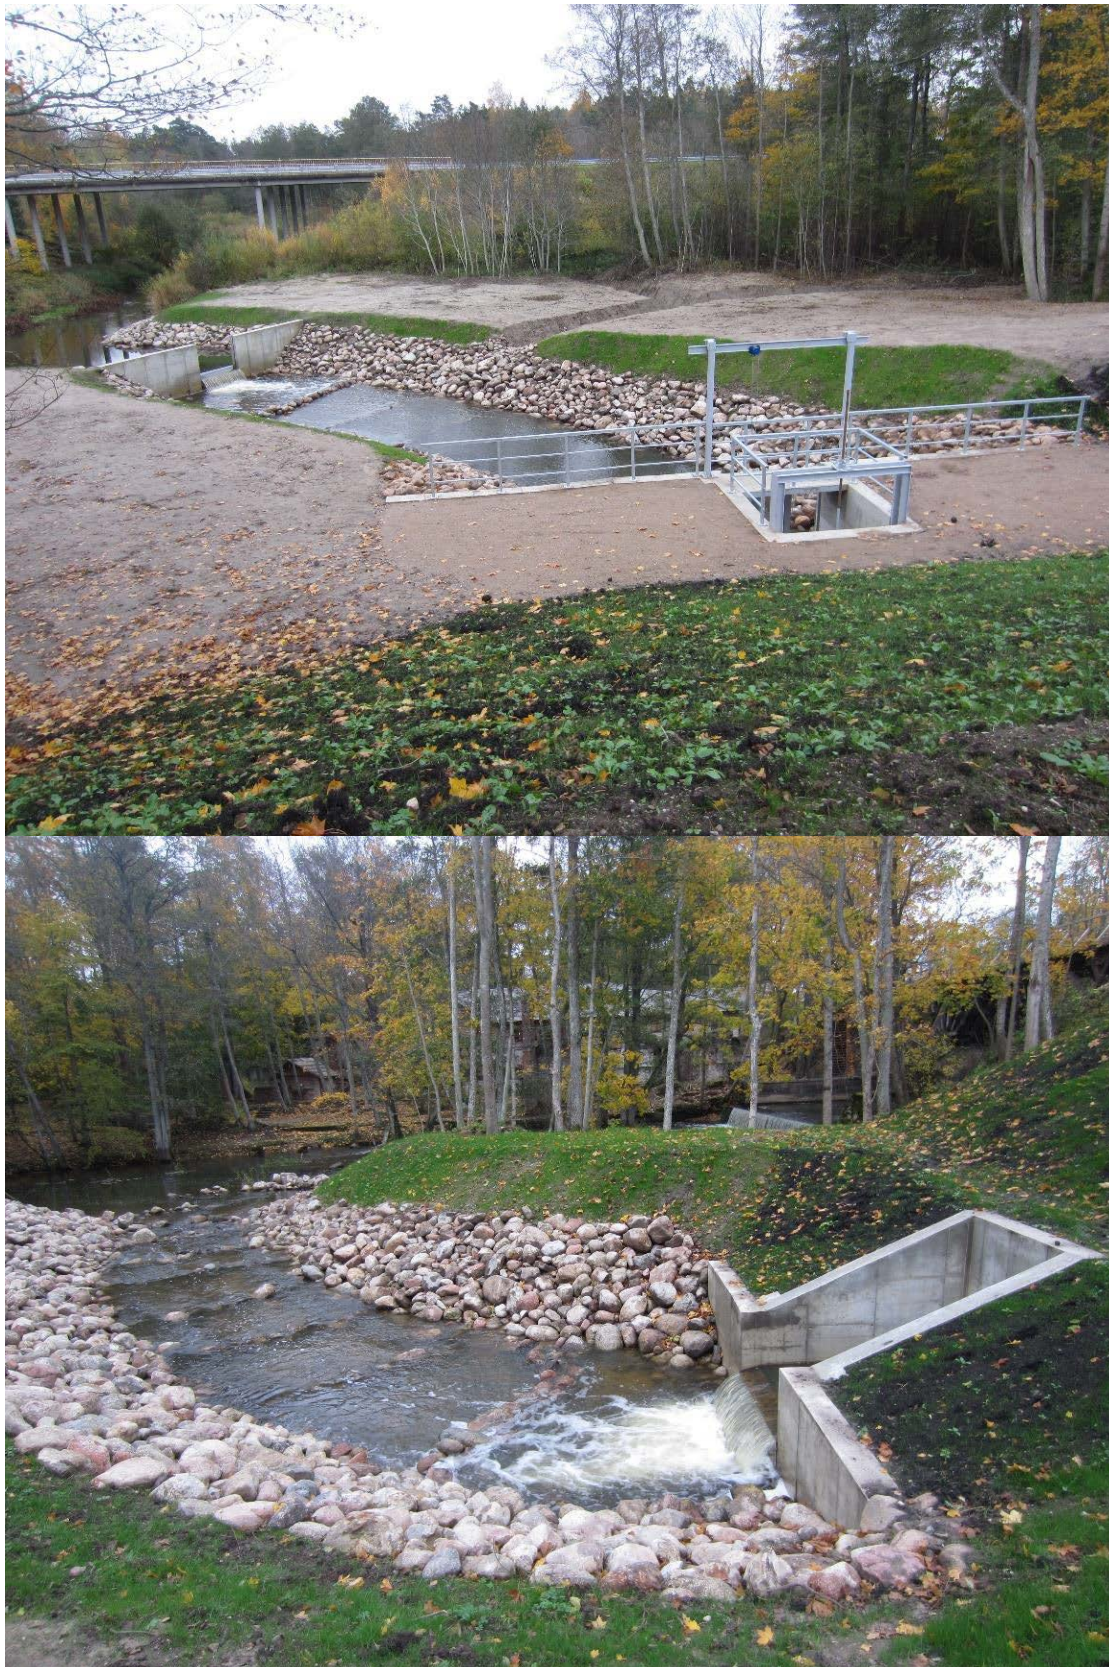
During further investigation it was made clear that the received alarmed signals from several parties about what is happening in the Rīva river were correct (Figure 25). So far, it had been announced with great confidence that the first natural fish pass in Latvia was being built in the Rīva river and it was to be suitable not only for sea trout but also for other fish and invertebrates. However, at this point the fish pass did not meet those expectations. It was found out that partly due to a faulty design and partly due to faulty construction work, the new fish pass had severe problems, inter alia in form of three new obstacles effectively obstructing fish migration. Also, 200 mm pipes had been laid in the channel controversially to aid fish migration. During low water conditions, there was extremely little water in the channel for the fish. It became clear that the design of fish pass in the late stage of the planning process had been changed without involvement or consultation of BIOR and RETROUT partners. The emerged concerns were expressed, and the involved parties started to search for a solution. Two meetings in the river side were held. A situation explanation and pictures were also sent to RETROUT project experts Martin Kesler (Estonia) and Robertas Staponkus (Lithuania), who also participated in a

meeting at Rīva river to provide external expert consultation. It was concluded that sufficient water in the fish pass was secured only during high flows (Figure 26); in medium and low flow conditions water flow over the obstacles is poor.

*Figure 25. The fish pass site after construction in October 2020. Photo credit: Ventspils county municipality.*

On 9th October 2020 a meeting was held with all Latvian restoration project partners, designers of the fish pass, constructors and local stakeholders. After long discussions, practical checking and measurements on the spot, a compromise solution that satisfied both scientists and local stakeholders was found. It was decided that the designers make the corrections in the design of the fish pass to ensure migration possibilities for different kinds of fish and at the same time secure enough water for the main channel to retain the artificial waterfall as a tourism attraction. Openings were to be made in both of the most crucial new obstacles. The dimensions of the openings were calculated so that the bottom of the opening was 10 cm lower than the bottom of pipe in the uppermost obstacle in the main river. And the width of the opening was calculated so that during the low flow the fish pass will consume approximately one half of the flow and other half will be left for the waterfall in the main river. In addition, parties agreed that the stone piles in the fish pass will be left unchanged and the upstream parts of the pipes in the stone piles will be clogged with smaller stones. The wooden shields in the uppermost part of the culvert were to be removed.

Changes in the construction were done properly and according to decided solutions and design. Additional costs caused by the situation were covered partly by the construction company within its responsibility and partly by the Ventspils County municipality. Thereafter the fish pass has been in operation. Further monitoring of the functionality of the fish pass in various conditions will be carried out during the coming seasons.

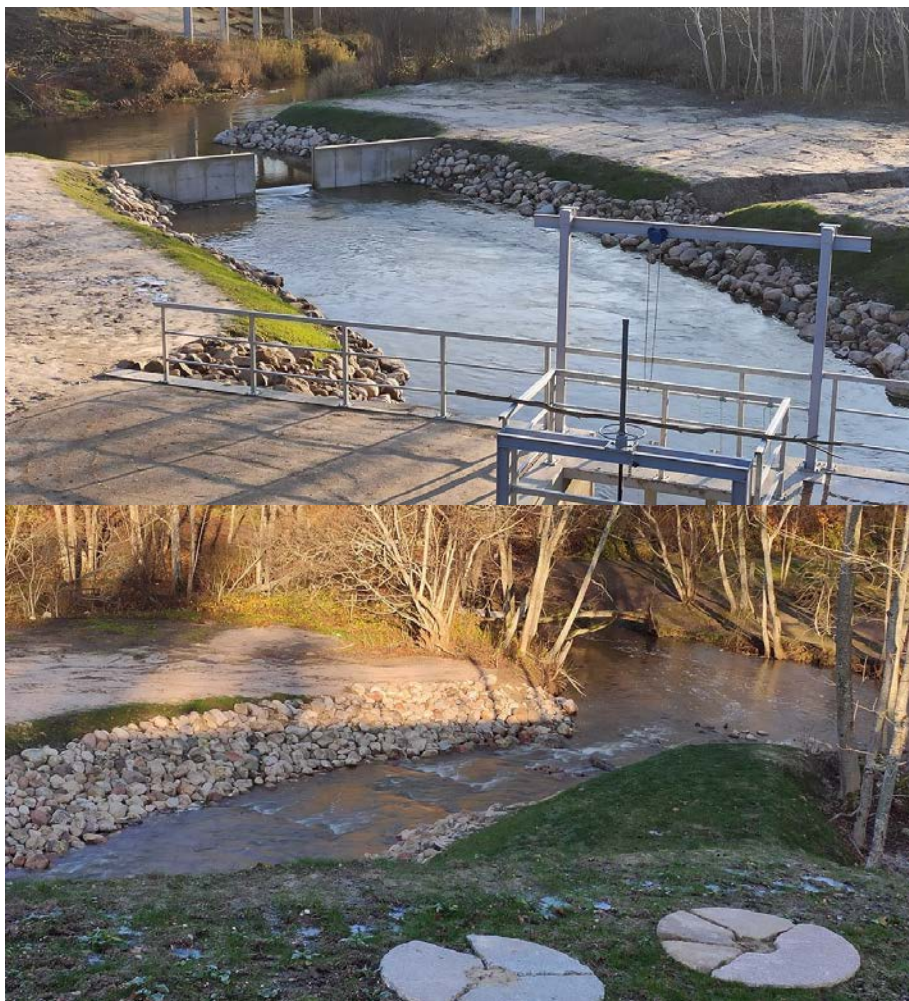
Figure 26. The fish pass during high flow conditions. Photo credit: Ventspils county municipality.

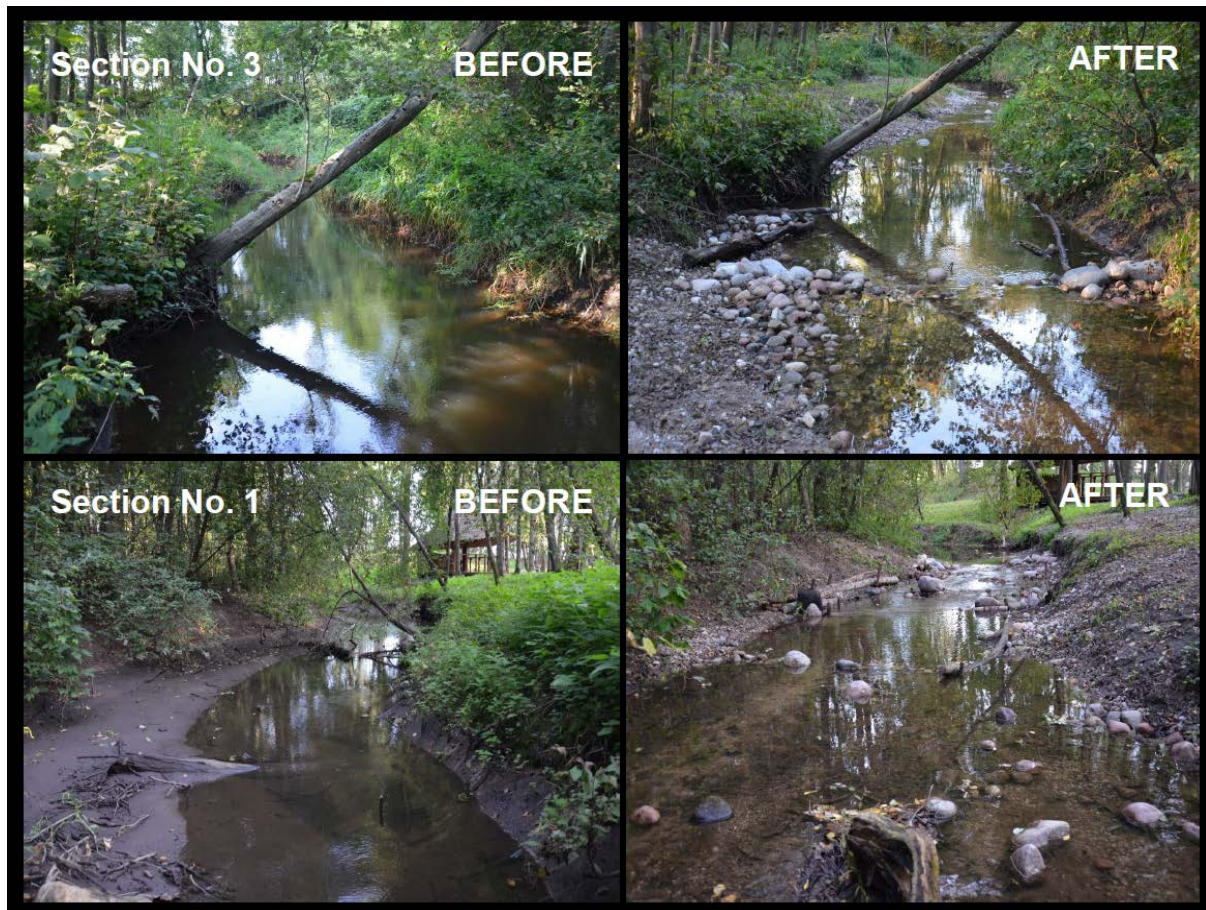
*Figure 34. Two river stretches that flows through the Jakų park where habitat improvement activities have been implemented. Before (left) and after (right) the restoration activities.*

The culverts forming migration obstacles were opened by removing the blocking concrete with the help of an excavator.

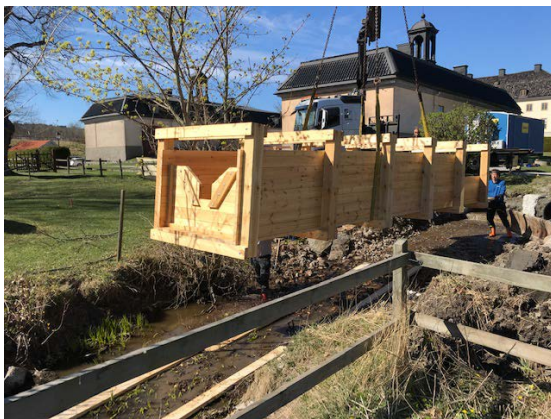
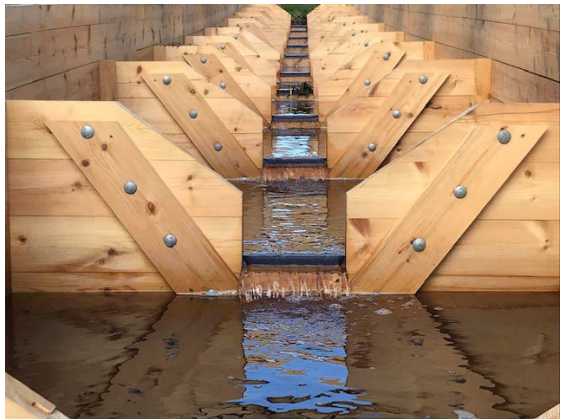
*Figure 59. The old fish pass is removed (upper left) and the new one is installed. When the leak was sealed all pools was filled as planned (lower right). Photo: Oliver Karlöf.*

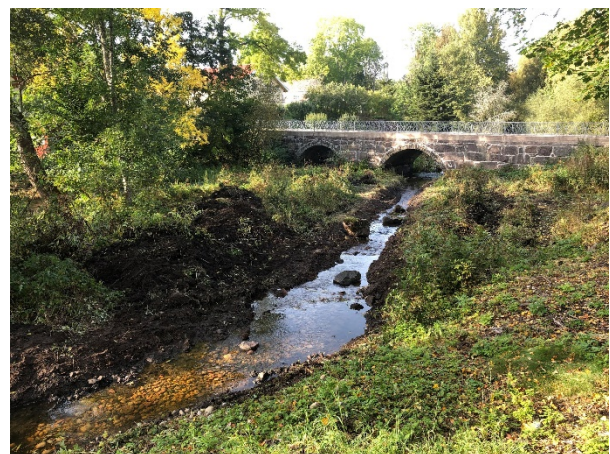
*Figure 80. Stretch 1b, Skebobruk, before (left) and after (right), a new multichannel stretch. Photo credit: Patrik Bergquist.*
