Estonia

River Valgejõgi: Kotka dam

River Valgejõgi: Nõmmeveski dam

River Kunda: Kunda lower hydroelectric power station (dam)

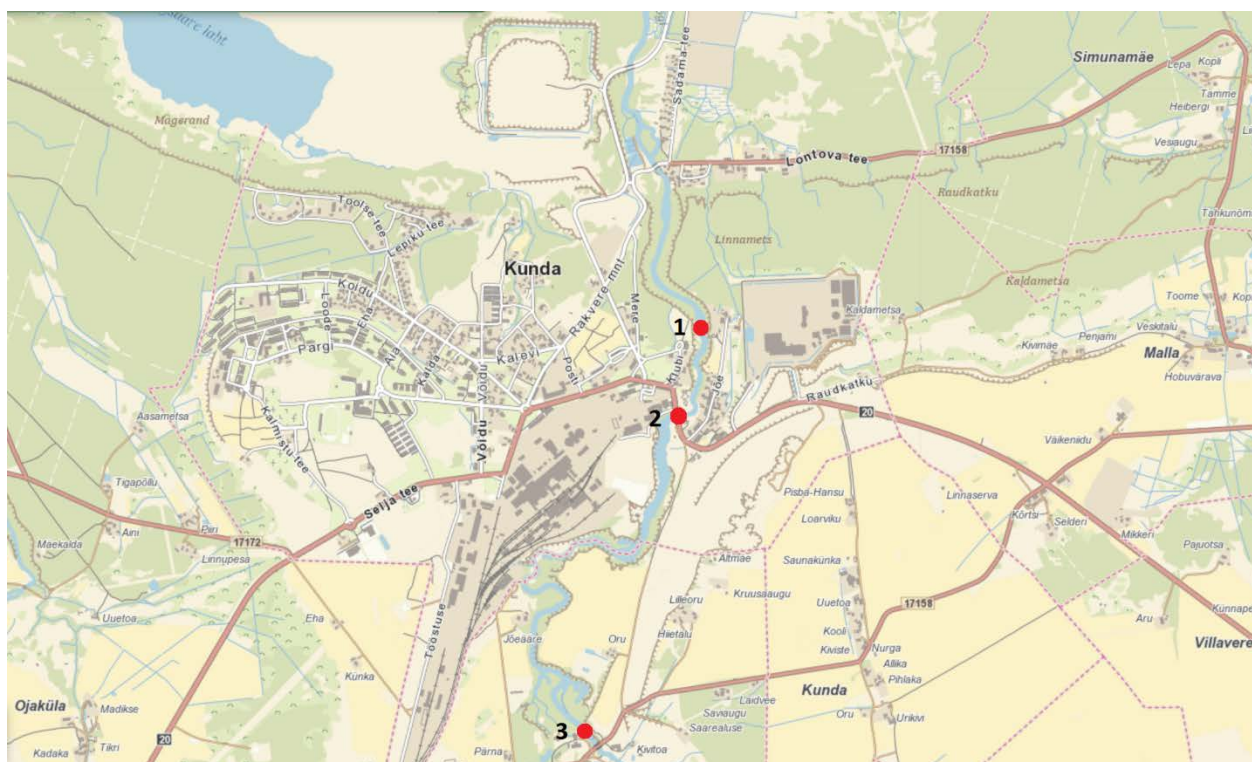
Figure 6. Migration obstacles on the lower part of river Kunda. 1. Kunda lower HEP, 2. Kunda second and 3. Kunda manor mill Source: www.maaamet.ee.

The Kunda lower hydroelectric power station (HEP) is located 2.3 km from the river mouth Kunda river (N 59° 30.1740' E 26° 32.5186'; Figure 6). The river is 82.2 km long and has a catchment area of 535.9 km². The elevation at the source is 90 m. Water quality of the river is classified as good. The river has wild native Atlantic salmon population that spawns only on the lower 2.3 km long part of the river. Salmon parr density below the dam is very high, however it comprises only about 10 % of the river's total potential spawning areas. In addition, sea trout, river lamprey and vimba bream also ascend to the lower part of river. For those species over 90 % of the suitable spawning areas are also located upstream of the dam. Resident trout, grayling and European bullhead exist throughout the watershed.

The Kunda manor mill dam is the third obstacle from the sea, 5.5 km from the river mouth (N 59° 29.1191' E 26° 31.8662'; Figure 6). Kunda river is 82.2 km long and has a catchment area of 535.9 km². The elevation at the source is 90 m. Water quality of the river is classified as good. The river has wild native Atlantic salmon population that spawns only on the lower 2.3 long river section. Salmon parr density on that section is high; however, it comprises only 10 % of the rivers potential spawning areas. In addition, sea trout, river lamprey and vimba bream also ascend to the lower part of river but over 90 % of the suitable spawning areas are located upstream of the dam. Resident trout, grayling and European bullhead exist throughout the watershed. There are no fish releases done in the river and all fish populations are considered wild and native.

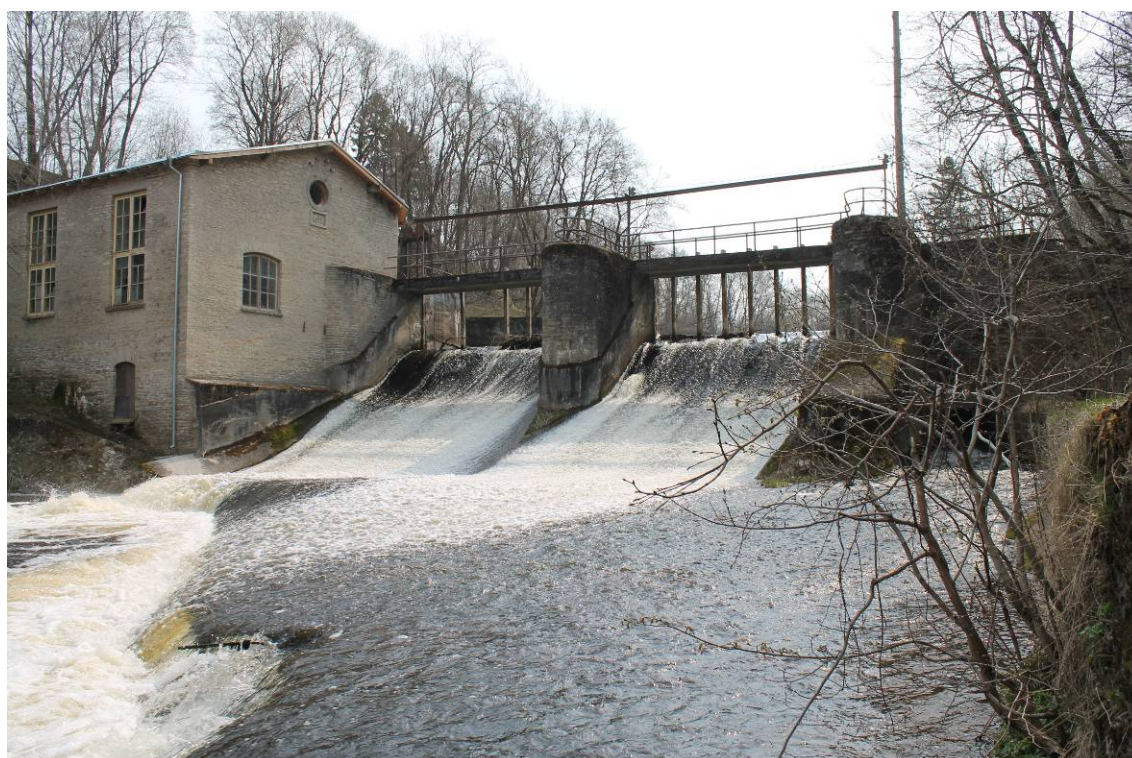
Figure 7. Kunda HEP is the lowermost migration obstacle on river Kunda. Most potential sea trout spawning areas are located upstream of the dam. Photo credit: Martin Kesler.

The Kunda lower HEP is the lowest dam on the river (Figure 7) and it is a complete migration obstacle for all fish. The planned solution must provide passage to all fish fauna, also those that are not good swimmers, e.g., sculpin. The dam was built in 1893 and operated as a hydropower station until 1971. The dam was restored and operated from 2000 to 2007. Its original height was 10.5 m, now it is 8.5 m. Wooden parts of the dam are missing and the HEP is not operational. The dam was designated as culturally valuable in 2008. Negotiations to buy the dam from private owners by the Estonian Ministry of Environment are ongoing. State ownership of the dam enables to plan for the most optimal compromise between the environment and cultural values. The dam is located in as steep valley and space for a passage solution is very limited. During early planning phase it became evident that at least partial removal of the dam is unavoidable for a viable passage solution. Through procurement a hydro engineering companies Eesti Veeprojekt OÜ and Inseneribüroo Urmas Nugin OÜ were hired to compose 3 alternative solutions for the dam. Preliminary environmental impact assessment (PEIA) for one alternative was carried out by AS Maves. It was concluded that environmental impact assessment (EIA) is not necessary to prepare as the objective of the planned works is to improve the environment.

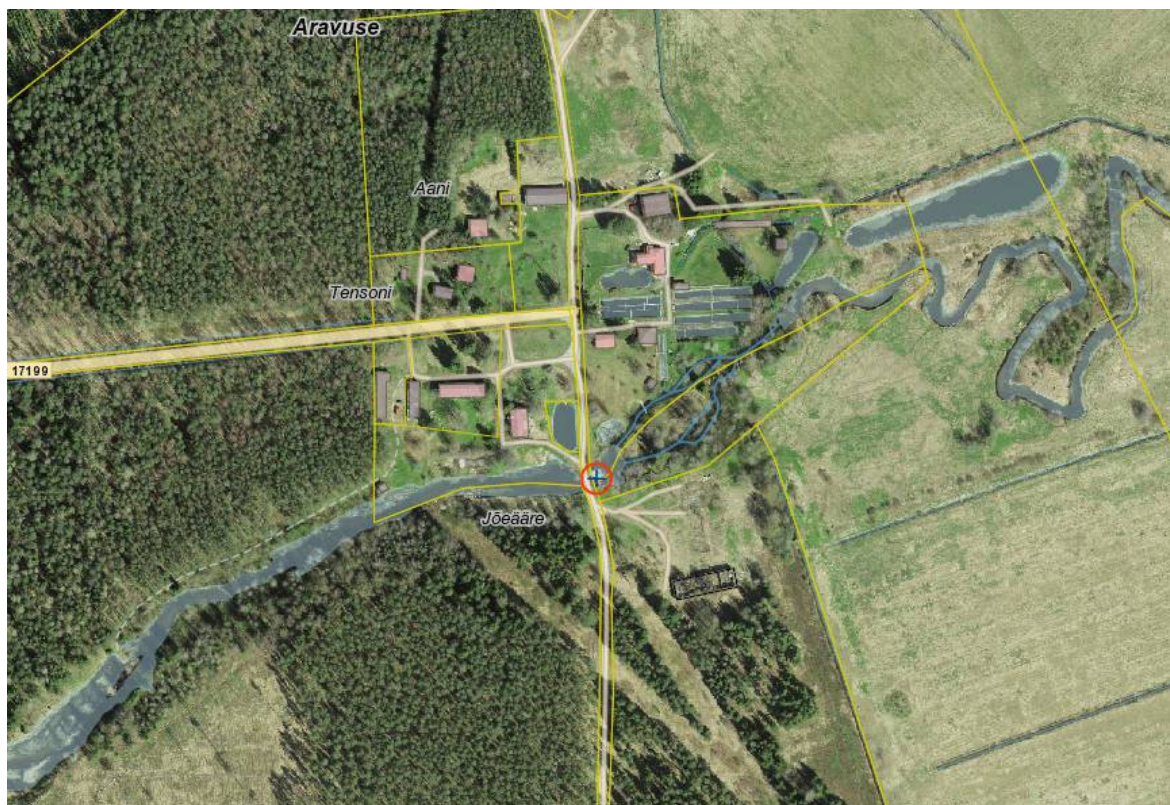
Figure 12. Location of Aravuse dam on upper river Kunda. Source: www.maaamet.ee.

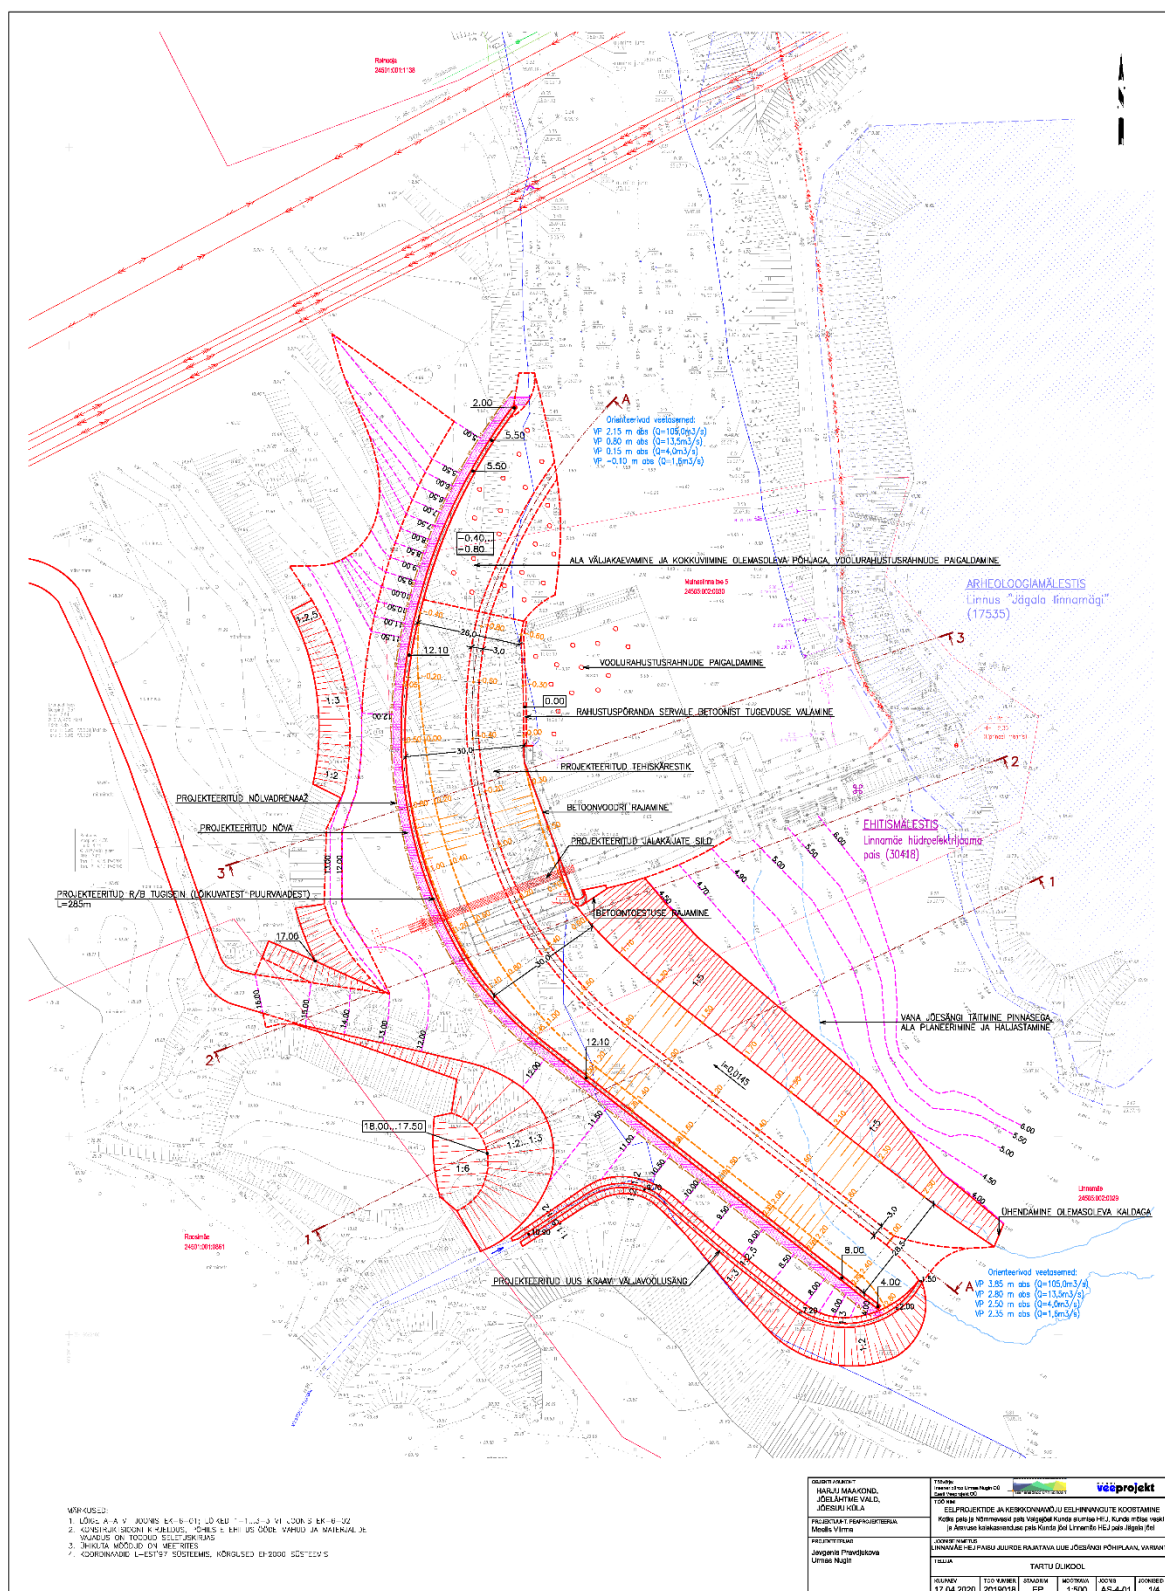
In the first alternative a 30 m long part of the dam on the left bank would be demolished, rest of the dam would remain intact. Water level will be lowered to pre dam level and new river channel to the left from the dam would be built. New river channel would be 200 m long and would have a slope of 1.45 %. To keep the left side of the valley stable, a 200 m long and up to 12.8 m high concrete wall would be built (Figure 16). A new bridge would connect the remaining dam with the opposite riverbank. The calculated cost of this alternative is 6 777 045 euros. This alternative retains most of the cultural values at the dam and provides free passage to all fish and aquatic life.

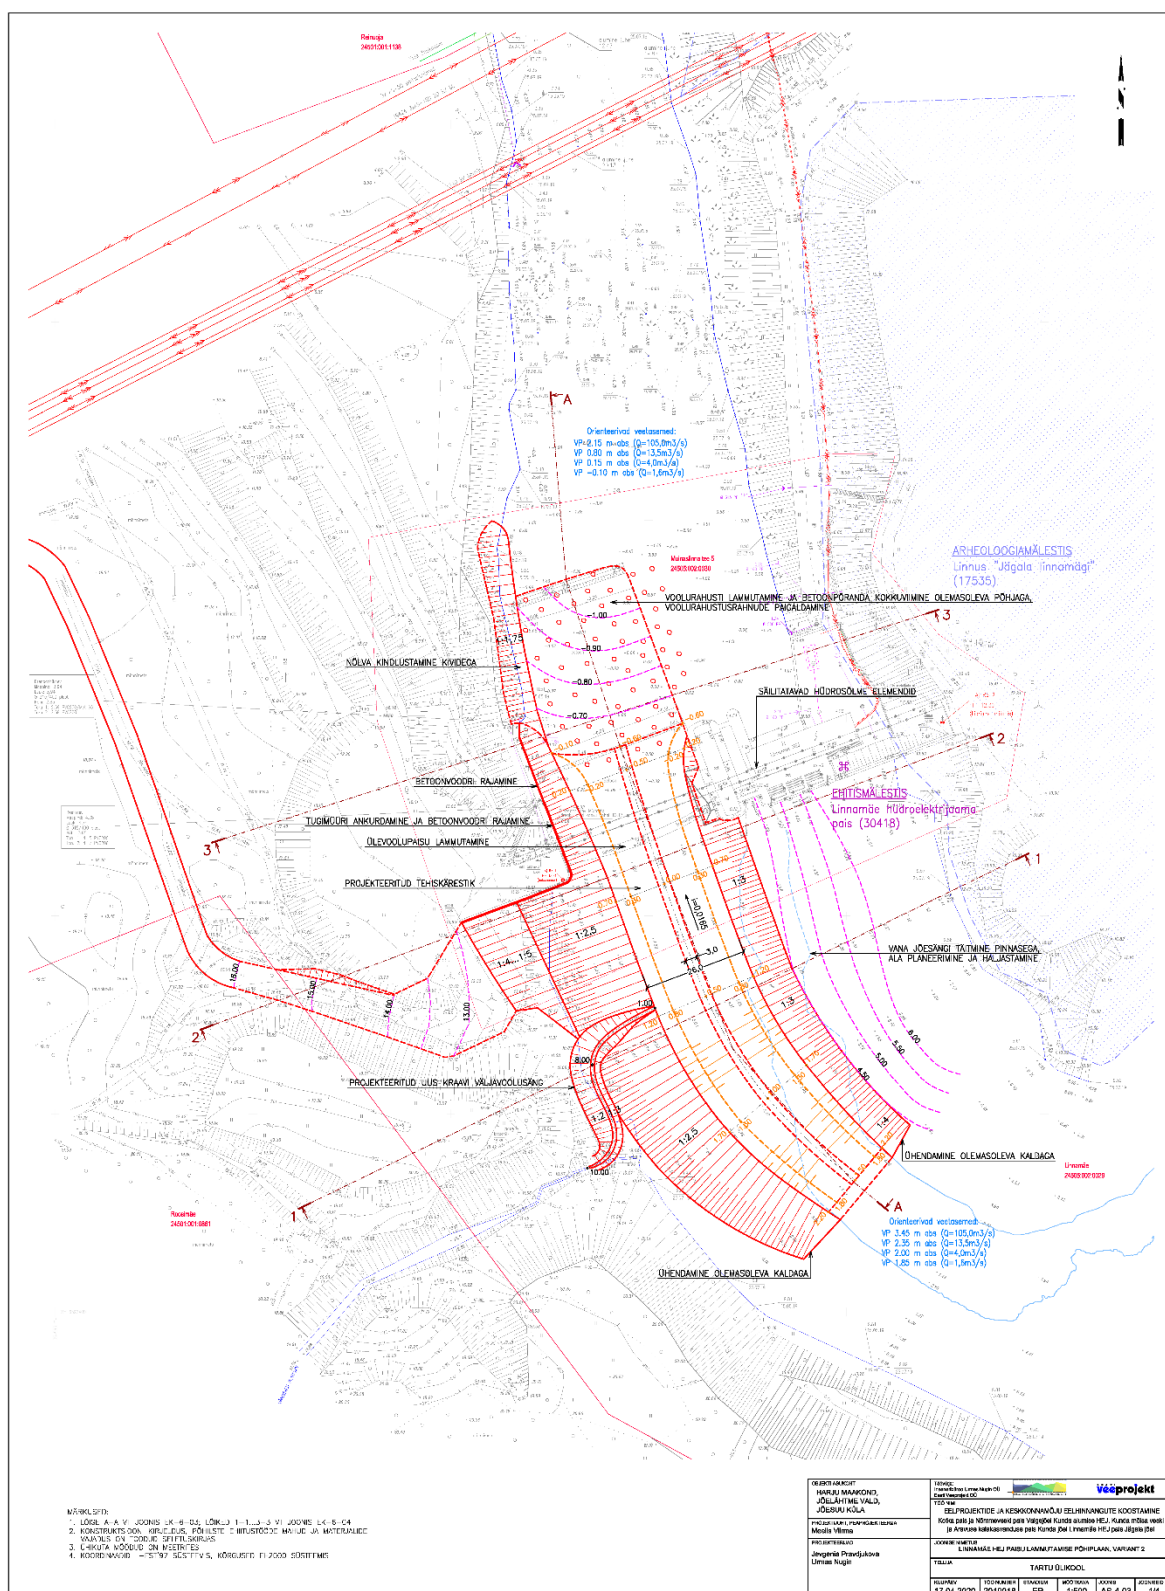
Second alternative is to remove the main concrete body of the dam and lower the water level to the original height. A 130 m long rapid with a 1.65 % slope would replace the dam and impounded lake area (Figure 17). Only the turbine building on the right side of the river would remain. This alternative would retain cultural values only partially and would restore the river close to its original state. The calculated cost of this alternative is 2 169 750 euros. The remaining turbine building needs maintenance and that cost is not included.

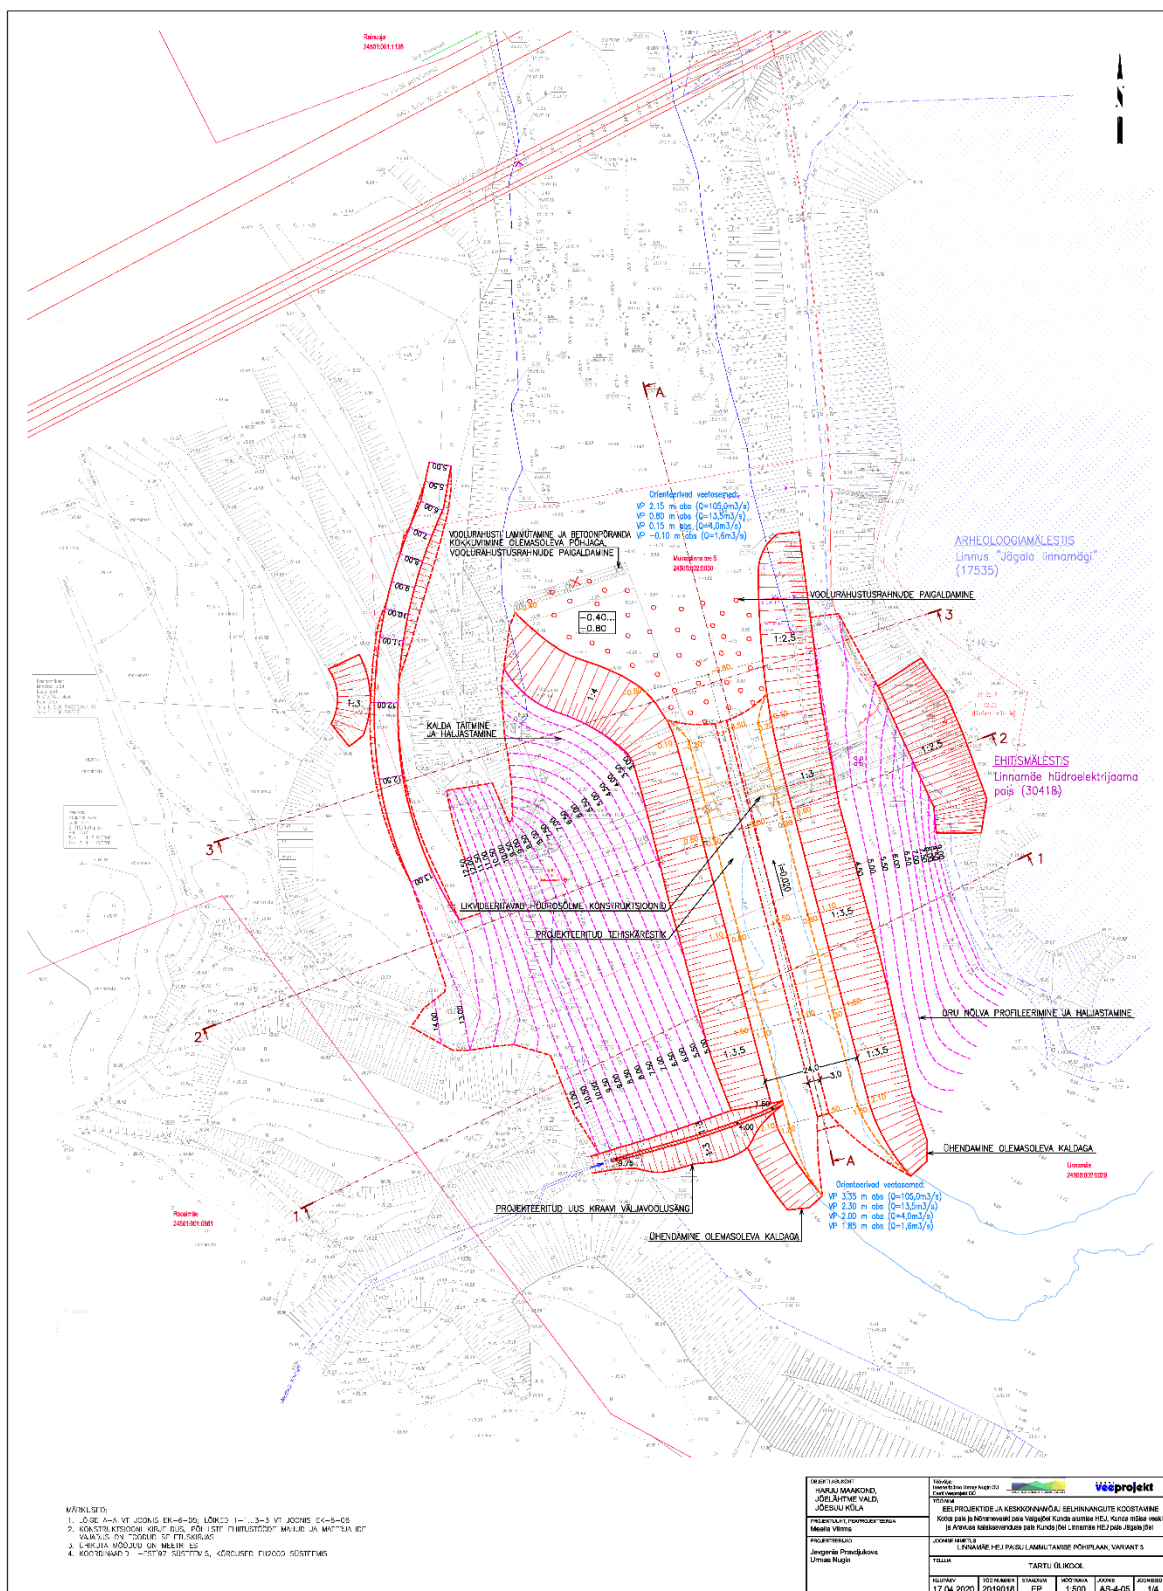
Third alternative is to remove all parts (including the turbine building) of the dam and restore the river and the valley close to its original state. Riverine conditions would be identical to the second alternative. In this case cultural values would not be preserved (Figure 18). Calculated cost of this alternative is 2 391 246 euros.
