Smeltalė river: restoration of biopond system and habitat improvement

Country	Lithuania
River	Smeltalė
Site	Švepeliai biopond and Jakų park
Type of sea trout population	Unique population, self-reproducing
Type of restoration	Restoration of biopond for nutrient reduction and habitat improvement
Temporal scale of the restoration	Long term
Spatial scale of the restoration	Biopond 500 m, park 200 m, 1 km apart
Responsible organization	Klaipėda District Municipality Administration
Duration of the project	1 year
Geographical location WGS84	55-42,2000N 21-15,2833E (Park) and 55-41,8500N 21-14,5667E (Biopond)
Total budget

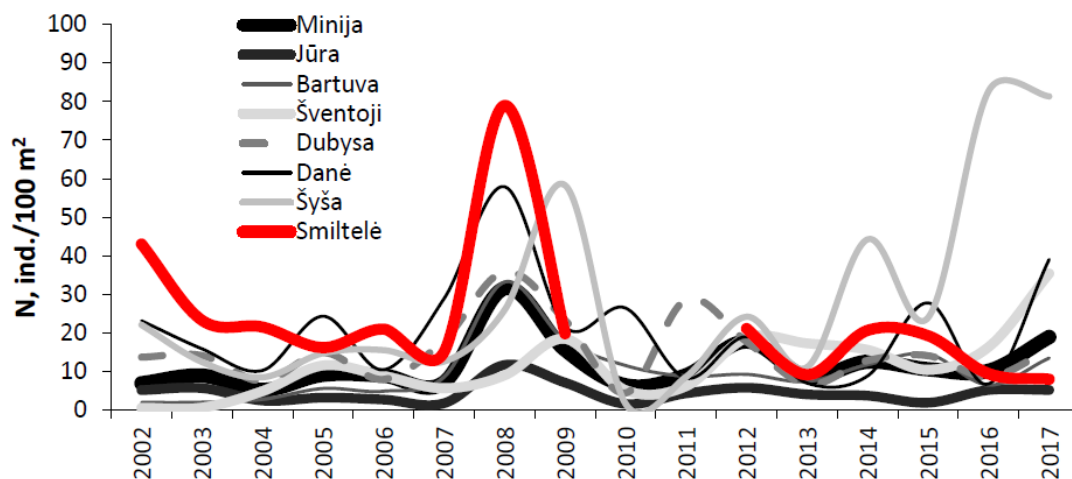
Figure 28. *Salmo trutta* population status dynamics in westerns Lithuanian rivers (Klaipeda University 2017).

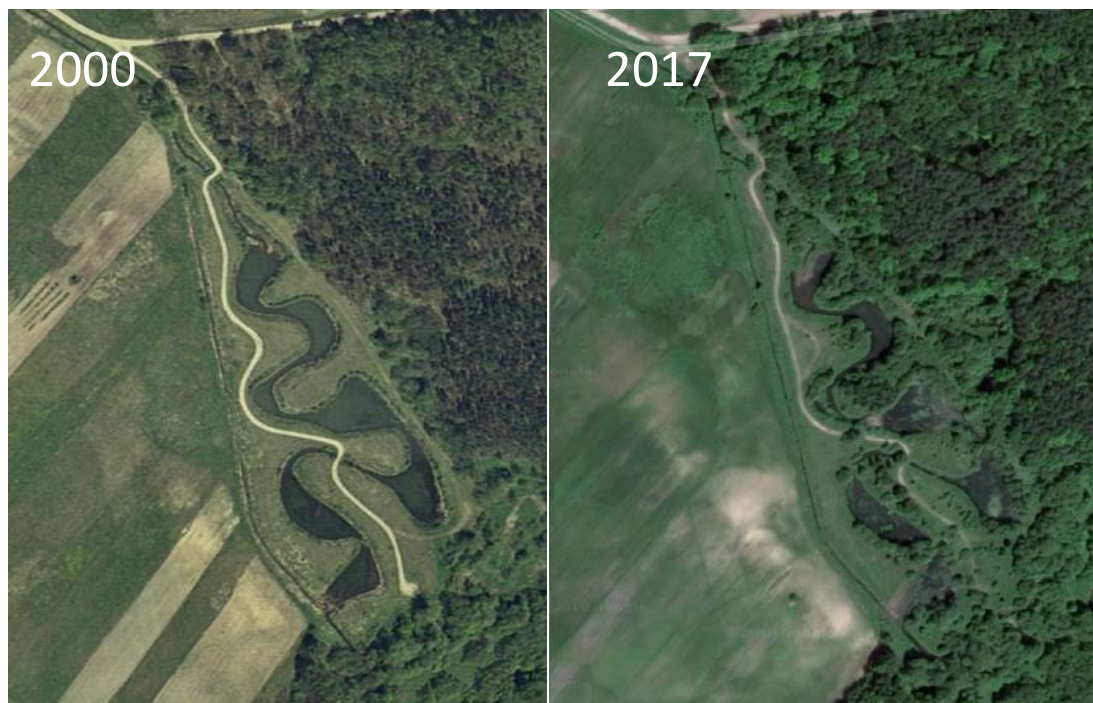
A biopond-system was established in 1996 at the confluence of the Smiltaitė and Smeltalė rivers to improve the water quality (Figure 27). Two hectares of land was turned into a wetland for river water treatment. It consists of several sedimentation ponds, anaerobic ponds, and aerobic ponds. Since then it has not been managed properly and it was suspected that the nutrient reducing efficiency had decreased. In 2018 the pond was completely overgrown (Figure 29).

Figure 29. The Biopond system four years after construction (left) and 21 years after (right).

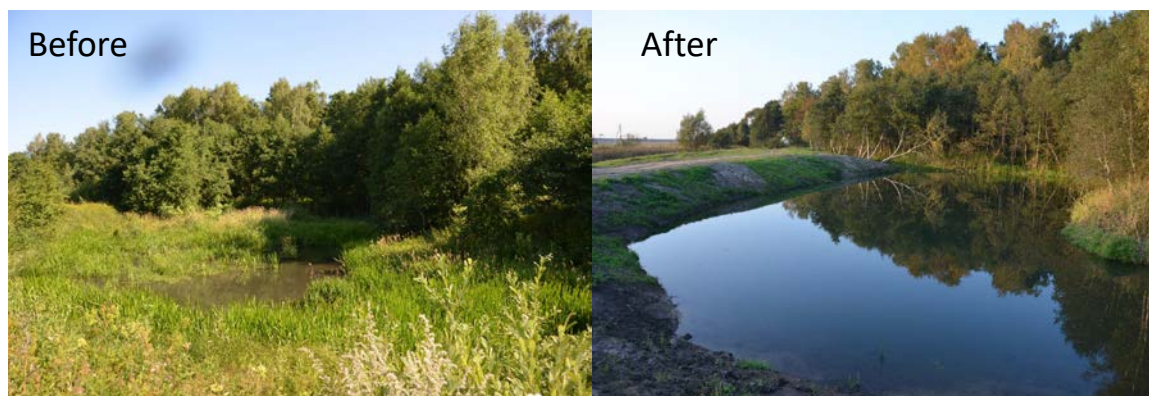
Figure 30. The Biopond system before (left) the restoration and after (right).

During the restoration 3300 m³ of sediment was removed from the pond and much of the overgrowth was cleared (Figure 30) the artificial weir was restored. The area is now used for recreation and education. A follow-up study of the nutrient reduction has not yet been performed.

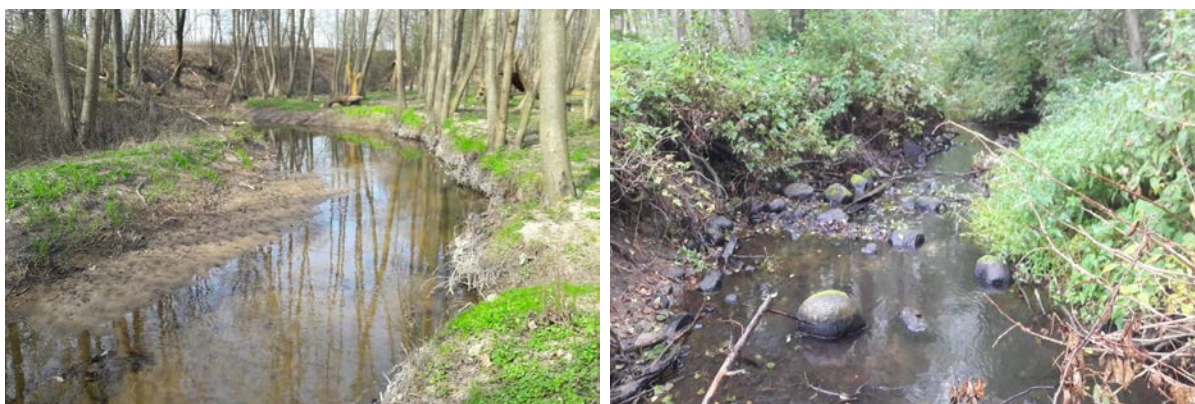
Figure 31. The restoration site (left) and the target site (right). The target site represents a habitat suitable for sea trout situated a few km upstream the restoration site.

To improve the suitability of the site for sea trout the riverbed has been modified because of lack of stones and gravel. A site which is known to be suitable for sea trout upstream the restoration site was used as a target (Figure 31). The planned actions included three sites, together 150 m and 600 m² where spawning grounds and nursery areas would be created (Figure 32). To ensure accessibility to the site, plans to remove the road culvert downstream the restoration site was made.

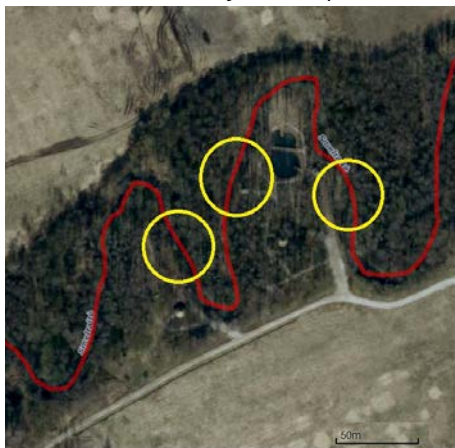
Figure 32. The three restoration sites in Smiltaitē river.
