River Bränningeån: habitat improvement

River Erstaviksbäcken: fish pass and habitat improvement

River Vitsån: habitat improvement

River Skeboån: Habitat improvement and plans for fish pass

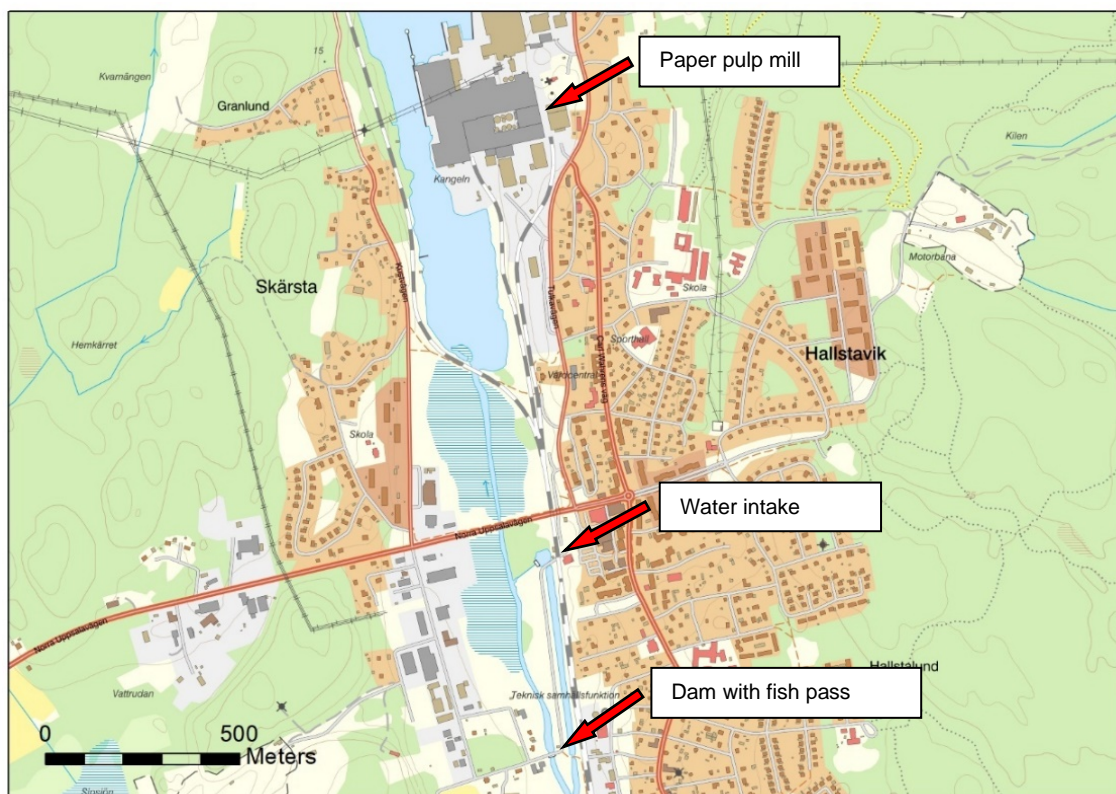
Close to the mouth in Skeboån, there is a dam with the purpose of providing a paper pulp mill with water (Figure 73). The water is led to the factory through a dug canal parallel to the river. In the end of the canal is a pond where the water intake to the factory is placed. In addition, the municipality waterworks has a water intake in the pond. The dam has a poorly functioning fish pass which is a migration obstacle for all fish except strong sea trout. In addition, it is open only 6 weeks a year and completely closed for fish migration the rest of the year. The paper pulp mill has permit to regulate water flow in all lakes in Skeboån river basin. The regulation is balanced to ensure enough water in the factory, which is operated around the clock all year round. The water flow from each lake is monitored and regulated manually. Extremely dry years (e.g., 2018) as much water as is allowed according to the permit has been drained from all lakes.

Figure 73. The dam at Hallstavik, Skärbrodammen.

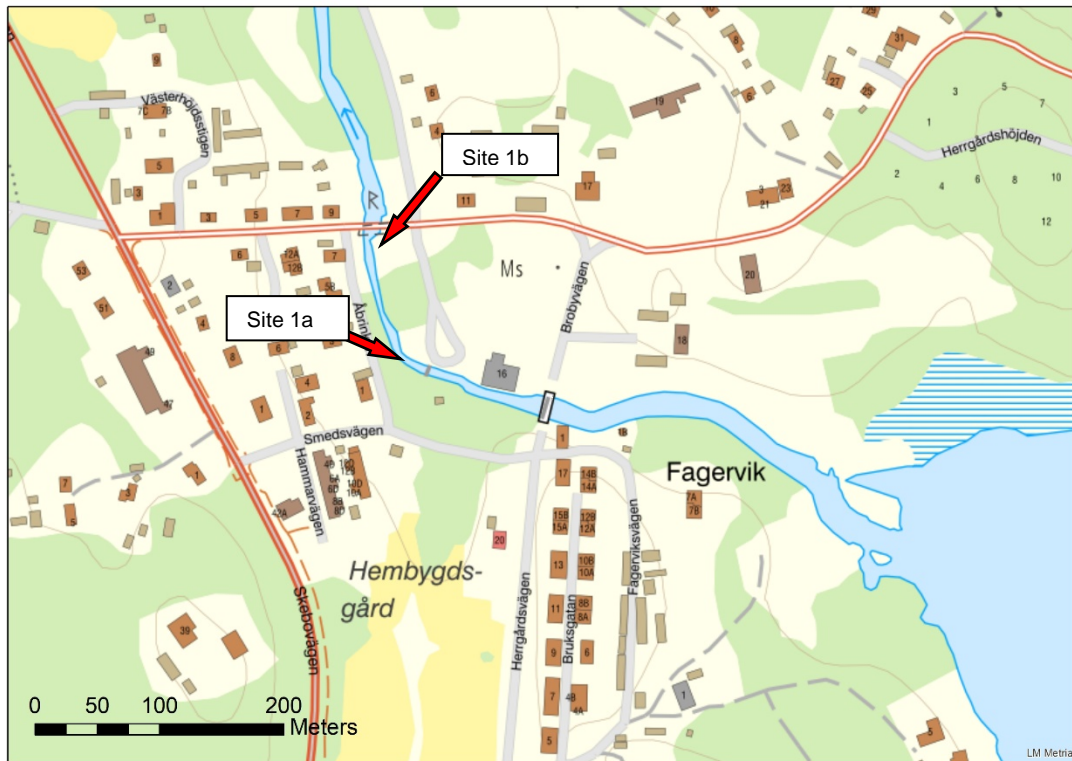
Figure 76. Stretch 1, Skebobruk old ironworks. At site 1a habitat improvement measures were applied, and at site 1b a multichannel stream was restored.

The Swedish Angling Society and the local fishing club, Skeboåns Sportfiske implemented the activities in end of September, early October 2020. In stretch 1, Skebobruk, a multichannel stretch was restored upstream an old bridge (Figure 76, 1a). The river was previously running through both arcs of the bridge, but one of the branches has become shallower over the centuries. It was now dug open with the aid of an excavator (Figure 79). At stretch 1b, 100 m upstream stretch 1a large stones and gravel were placed in the stream to create holding spots and spawning grounds (figure 76, 1b). About 40 tonnes of boulders and 30 tonnes of gravel were put in the stream.

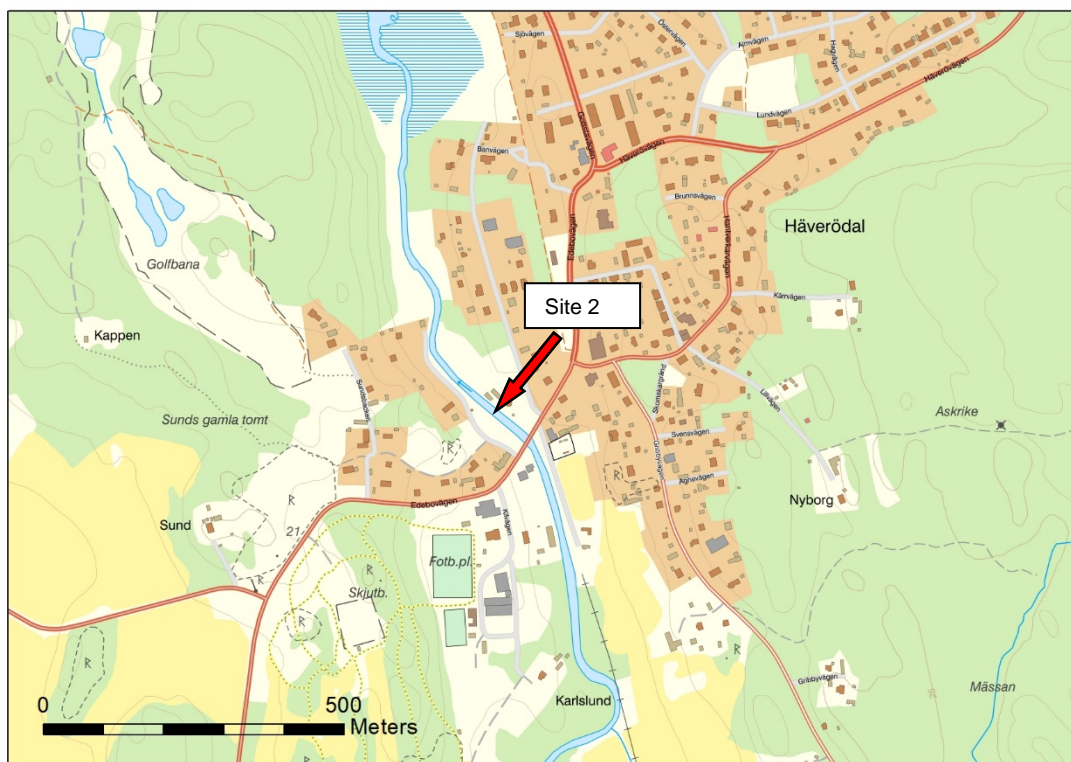
Figure 77. Stretch 2, Häverödal old mill and saw. Here habitat improvement measures were applied, and a controlling section partly restored.

At Häverödal the formerly cleared river has now a more variable structure and a partly restored controlling section. Already 32 sea trout have been observed to spawn at the newly restored stretch. The electrofishing and redd counts next and the following years will give us more information about the result of the restoration activities.

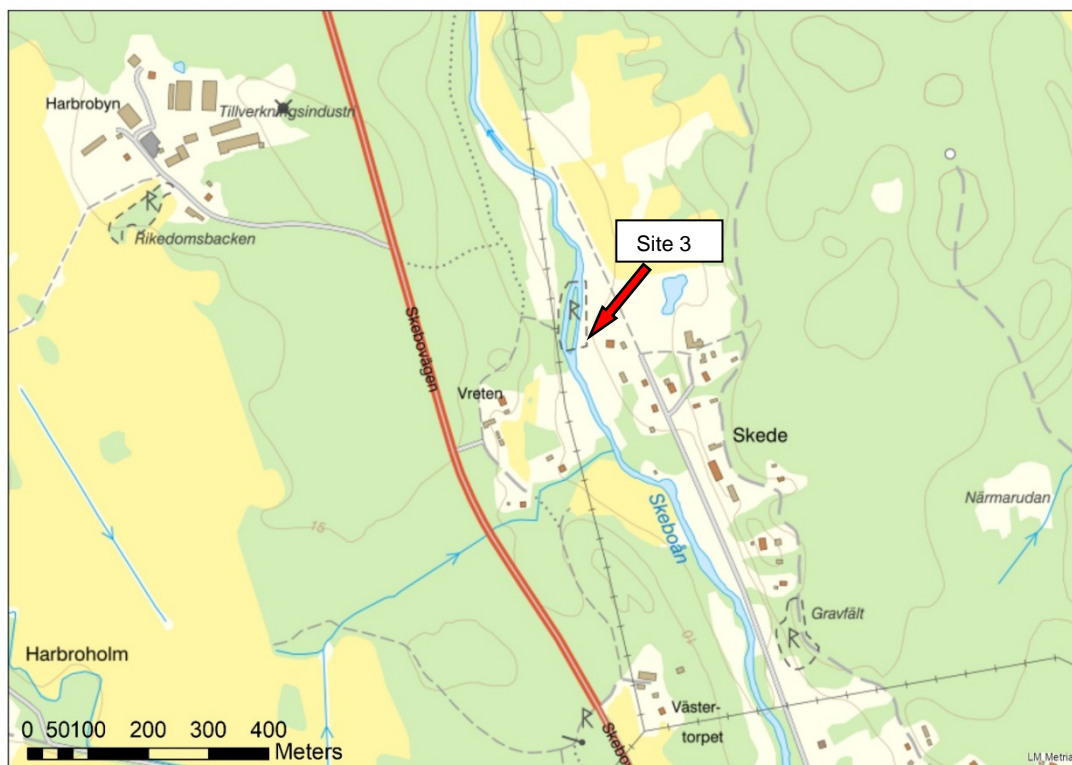
Figure 78. Stretch 3, Skede ironworks. Here, habitat improvement measures are planned. The site is a historic site protected by the Ancient Monuments Act.

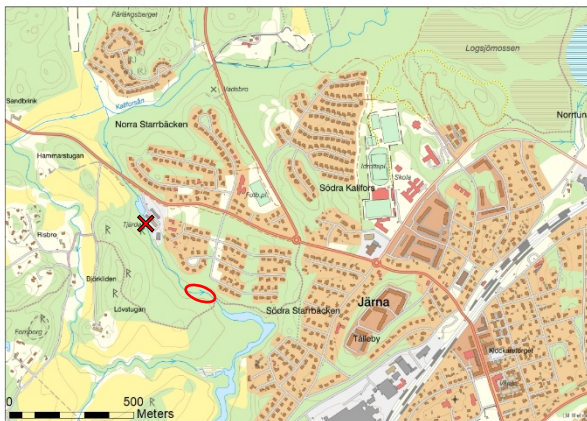
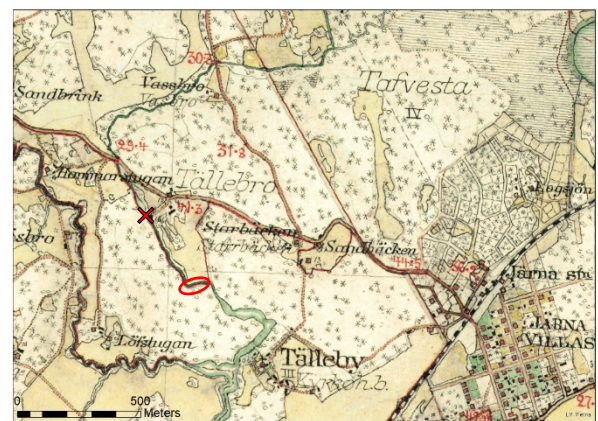
One and a half km upstream the dam in Järna there is a stretch which has been redug and cleared (Figure 84). Judging from a map from 1696 the river took another way at that time (Figure 88). It is not

clear why the rivers' path has changed, but on the map from 1901 it has its present path (Figure 84). The site is suitable for habitat improvement measures because the water has fast enough flow to create a riffle and pool system by adding large stones, logs, and gravel. This hydromorphological type is rare in Moraån but has most likely been more common earlier.

Figure 84. Restoration site in Kallforsån. Present (left) and year 1901 (right). The x-signs indicate migration obstacles. Source: LM Metria ©.

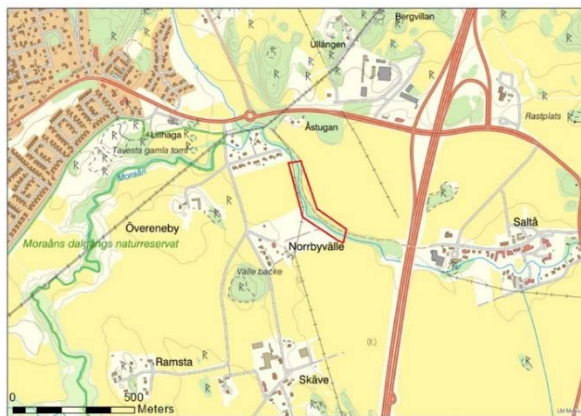
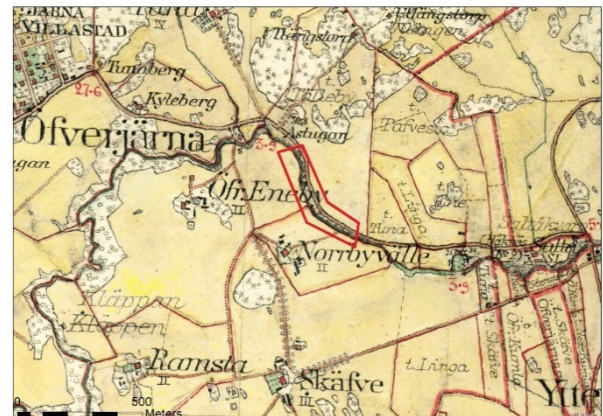
Just downstream the nature reserve Moraåns dalgång (the Moraån valley) is a stretch which have been redug and cleared, but still has moderately fast flowing water (Figure 85). The riverbanks are tree lined but steep because of a removed controlling section downstream (Figure 86). Hence, the river has lost contact with the original flood plain and secondary flood plains have started to form. The stretch is suitable for habitat improvement measures including adding stones and gravel to the river because the water is not completely calm, and the riverbed is not too soft; added stones will not be buried in sediment. By adding large stones, logs, and gravel we hope to increase biodiversity and create holding spots and spawning grounds for sea trout.

Figure 85. Restoration site at Norrbyvälle. Present (left) and year 1901 (right) The x-signs indicate migration obstacles. Source: LM Metria ©.

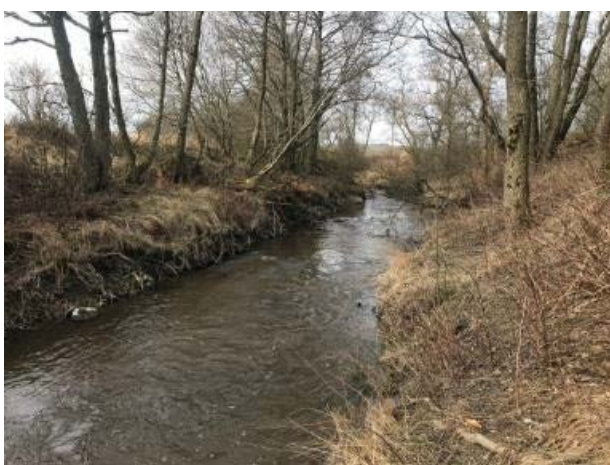
Figure 86. Restoration site at Norrbyvälle. Photo: Ekologigruppen AB.

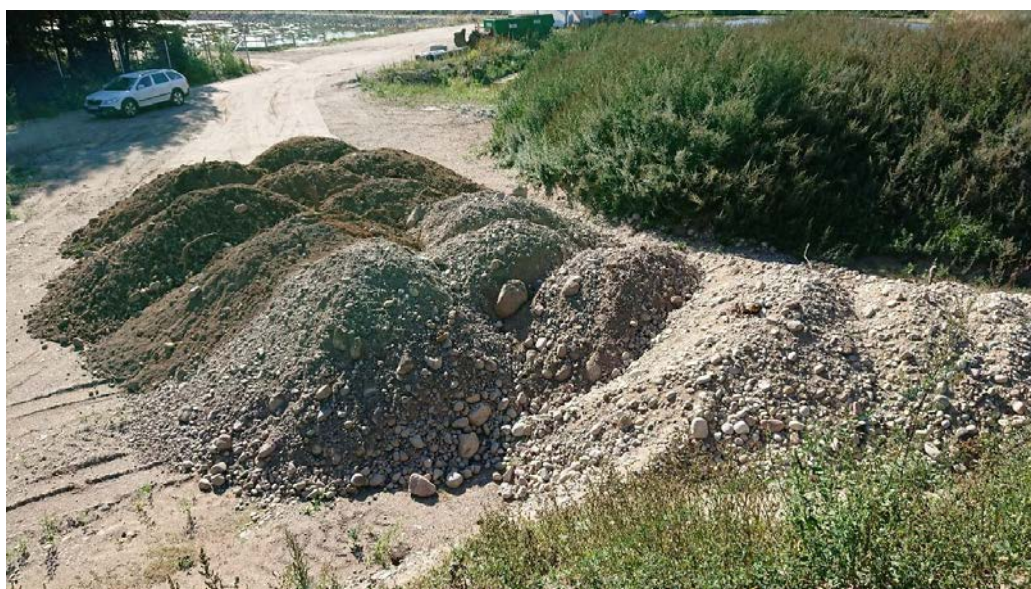
Figure 89. Stones and gravel to be used for habitat improvement activities in Kallforsån. Photo Tobias Fränstam

About 250 tonnes of large stones and gravel were put in the river with a 2-tonnes tracked dumper and a 23-tonnes tracked excavator (Figure 90). A place, most suitable for stocking of stones was chosen in consultation with the municipality (Figure 89). During the work the ground was frozen, which reduced the risk for driving damage on ground and roots. To reduce it further, excavator mats were used. Driving damage that nevertheless arose were repaired when the work was completed. The excavator was operated by a skilled person with experience from similar work. Biological expertise was present during the hole implementation phase, supervising the work. To cause as little disturbance as possible to plants and wild animals, the work was conducted during winter.

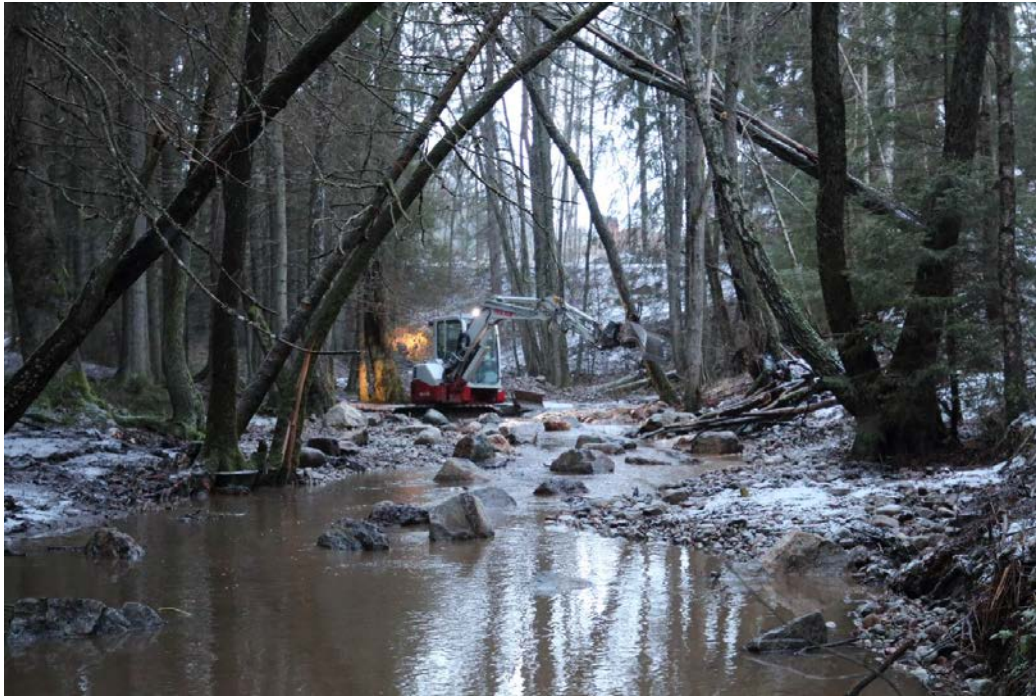
Figure 90. Work underway in Kallforsån. Photo Tobias Fränstam

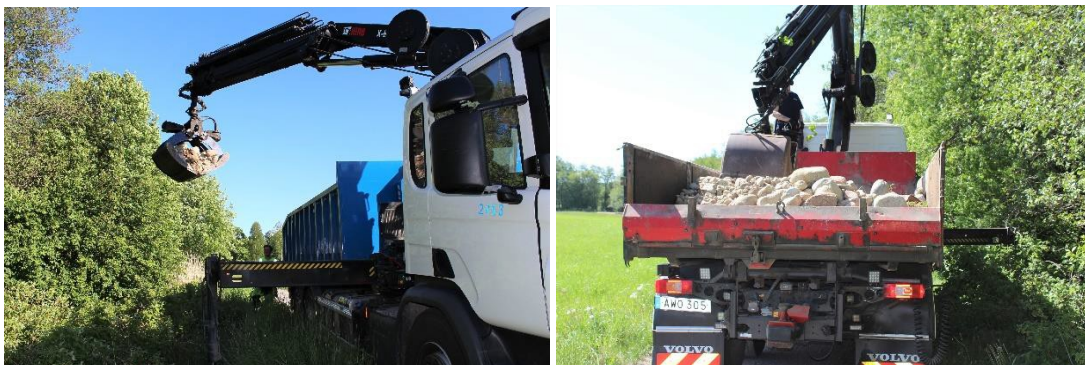
Figure 91. Two crane trucks were used to deliver the stones. Photo Mikael Lindén

The work at Norrbyvälle was implemented by Södertälje municipality in collaboration with the County Administrative Board of Stockholm. The measures were implemented 2-3 June 2020. Approximately 190 tonnes of gravel and stones were placed in the river during the restoration activities. Crane trucks picked up the material about 15 km away aided by a wheel loader. The stretches were located along a pedestrian and bicycle path (Figures 91) where the trucks could stand while they lifted down both gravel and larger stones to the river (Figure 92). The material was distributed fairly evenly along the stretch. Where necessary, branches were sawn off to avoid damage to the hydraulic hoses (Figure 93). Down in the river, the material was moved with a filling hammer, skewers and by hand to create as varied stretches as possible.

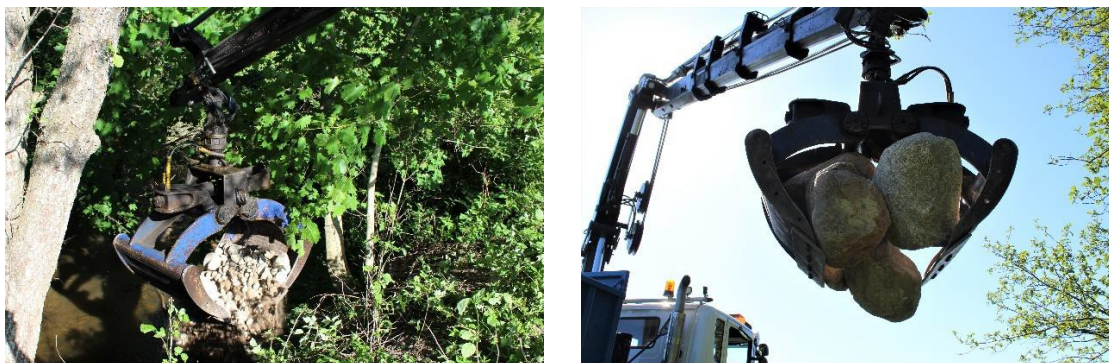
Figure 92. Both large and small stones were used. Photo Mikael Lindén

Gravel was used to create spawning grounds while larger rocks were used to create holding spots and build necks that provide flowing water downstream and calmer / deeper water upstream.

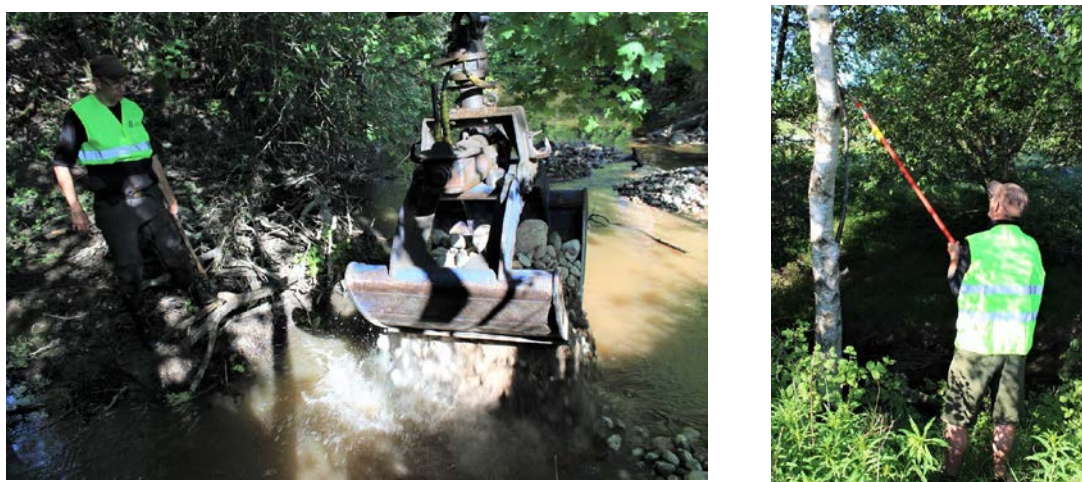
Figure 93. The crane releases its load in the river. The stones were then rearranged to create the wanted structures (left). Some branches had to be cut off to enable the crane to reach the river (right). Photo Mikael Lindén

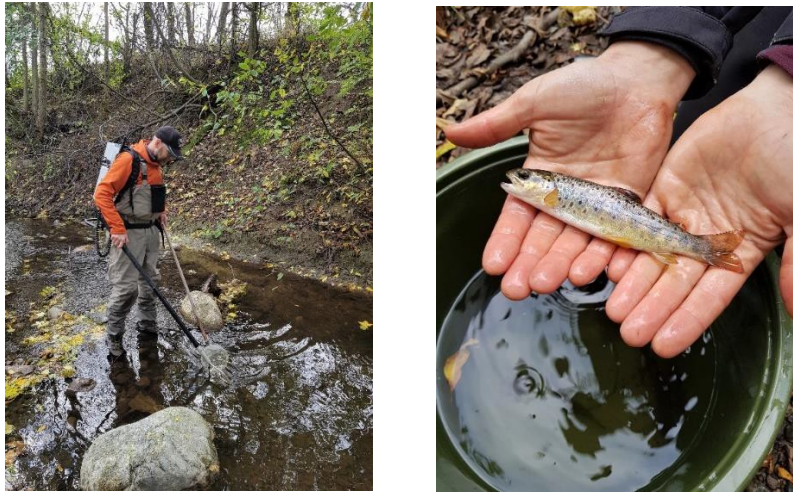
An attempt to electrofish the stretch at Norrbyvälle was made during October 2020 (Figure 96). Unfortunately, the equipment broke down during the work wherefore no complete results were achieved. However, some fish were caught; 10 trout yearlings, 4 older trout and one bullhead (*Cottus gobio*). A complete electrofishing monitoring will be performed during 2021.

Figure 96. Electrofishing at Norrbyvälle (left). A young sea trout (1+) (right). Photo: Mikael Lindén.
