# RETROUT River Restoration Demonstration Case Reports

## RETROUT project report

For bibliographic purposes this document should be cited as: "RETROUT 2021. RETROUT River Restoration Demonstration Case Reports. Interreg RETROUT project.

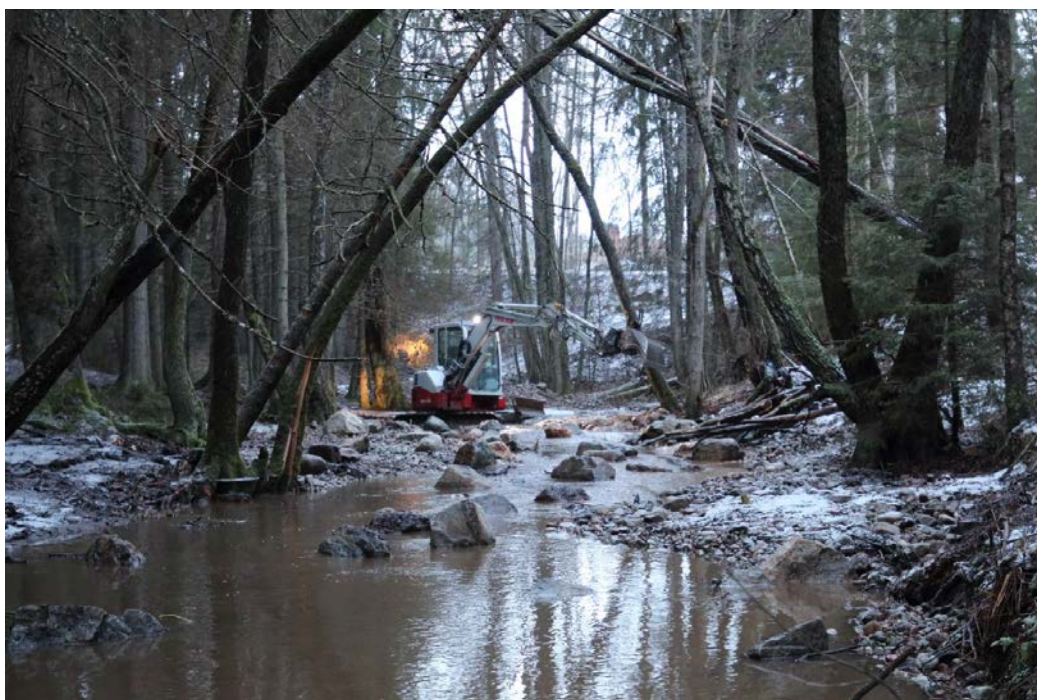
Figure 90. Work underway in Kallforsån. Photo Tobias Fränstam

About 250 tonnes of large stones and gravel were put in the river with a 2-tonnes tracked dumper and a 23-tonnes tracked excavator (Figure 90). A place, most suitable for stocking of stones was chosen in consultation with the municipality (Figure 89). During the work the ground was frozen, which reduced the risk for driving damage on ground and roots. To reduce it further, excavator mats were used. Driving damage that nevertheless arose were repaired when the work was completed. The excavator was operated by a skilled person with experience from similar work. Biological expertise was present during the hole implementation phase, supervising the work. To cause as little disturbance as possible to plants and wild animals, the work was conducted during winter.

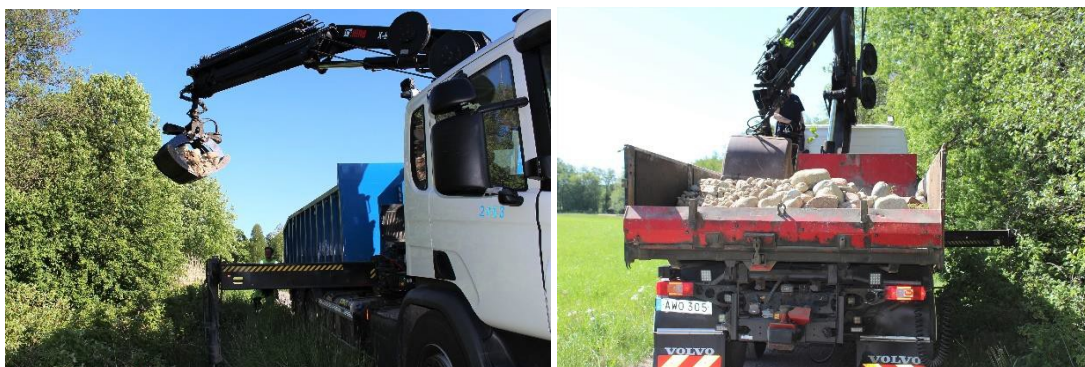
Figure 91. Two crane trucks were used to deliver the stones. Photo Mikael Lindén

The work at Norrbyvälle was implemented by Södertälje municipality in collaboration with the County Administrative Board of Stockholm. The measures were implemented 2-3 June 2020. Approximately 190 tonnes of gravel and stones were placed in the river during the restoration activities. Crane trucks picked up the material about 15 km away aided by a wheel loader. The stretches were located along a pedestrian and bicycle path (Figures 91) where the trucks could stand while they lifted down both gravel and larger stones to the river (Figure 92). The material was distributed fairly evenly along the stretch. Where necessary, branches were sawn off to avoid damage to the hydraulic hoses (Figure 93). Down in the river, the material was moved with a filling hammer, skewers and by hand to create as varied stretches as possible.

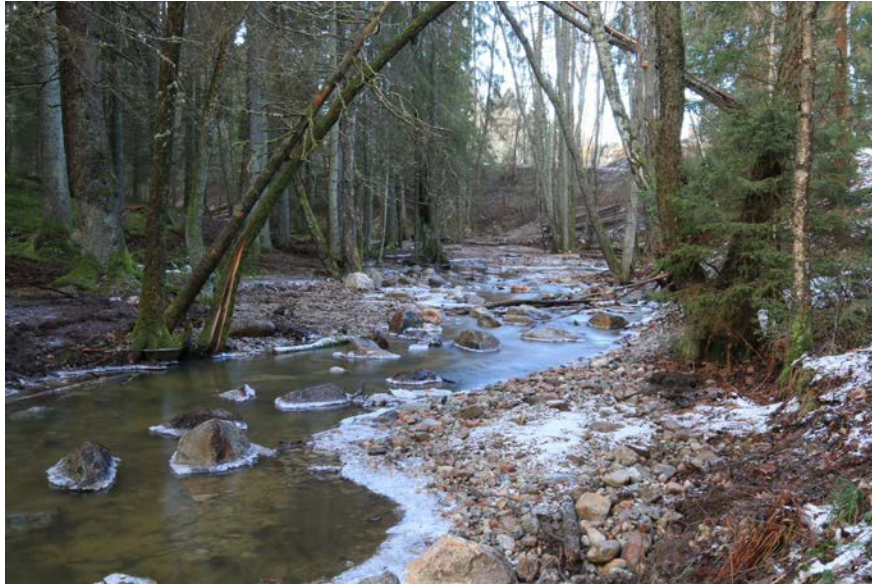
No electrofishing has been done yet, but are planned to be performed during 2021. Regarding the hydromorphological properties of the stretch, the restoration activities was a success. The previously cleared stretch has now a very fine and varied stream water environment with potentially high values for aquatic fauna, especially as a spawning and rearing environment for trout (Figure 94 and 95). It may however be considered a failure that the public opinion, at least in part, was negative to the activities since they had not been reached by information about it. It is not known if this negative opinion persists.

*Figure 94. Work completed. Kallforsån 2019. Photo Tobias Fränstam*
