River Rīva: remains of old paper mill dam

Country	Latvia
River	Rīva
Site	Labrags
Type of sea trout population	Original population
Type of restoration	Construction of natural like fish pass across the remains of old paper mill dam to ensure the access to spawning and rearing grounds upstream this barrier
Temporal scale of the restoration	Long term
Spatial scale of the restoration	All river
Responsible organisation	Kurzeme Planning Region and Ventspils Regional Municipality
Duration of the project	2 years
Geographical location WGS84	56.973351N, 21.348703E
Total budget	220 000 €

Construction of the fish pass on Rīva River in Jūrkalnes parish, Ventspils county, Latvia.

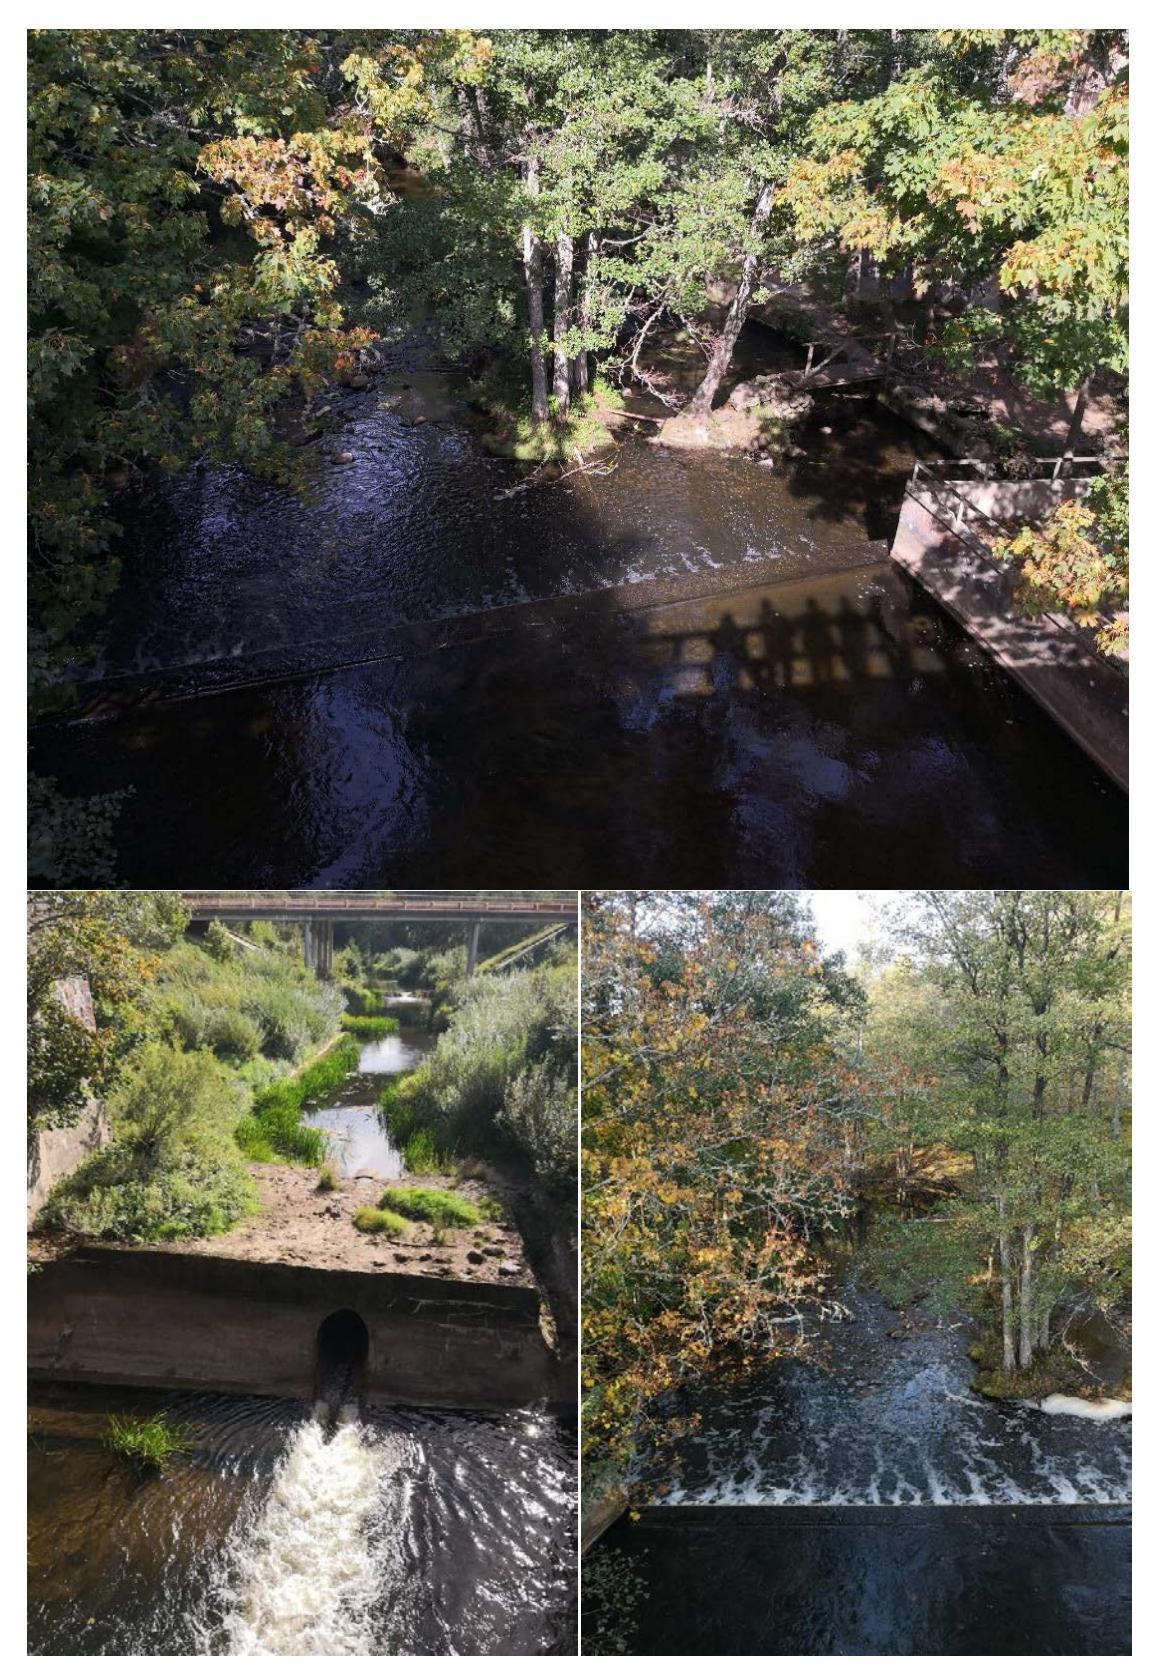
Figure 19. Photos of the Rīva river restoration site before the restoration was started. Photo credit: Ventspils county municipality.

- The project aims to facilitate fish migration to the greatest part of the river. A migration barrier, in form of the remains of an old paper mill dam (Figure 19), is located approximately 1.2 km from the sea (Figures 20–21). Approximately 98 % of the riverbed is located upstream this barrier.

Approximately 1.2 km from the river mouth of Rīva river is the 19th century-built ruins of a paper mill. A 3-stage concrete (masonry) barrier has been preserved along the entire width of the riverbed. As the dam does not allow migration of several fish species, a solution to overcome the barrier was needed. Therefore, the primary aim of the initiative was to ensure migration of anadromous and other fishes to the part of Rīva river and its tributaries currently blocked by the remains of a paper mill dam. A re-establishment of migration possibilities provides immediate opportunities for migratory fish, such as sea trout, to reach and utilise much larger river areas with suitable spawning and rearing habitats. In addition, opening of a migration route paves the way for future projects of restoration of sea trout and River lamprey spawning and rearing habitats upstream the dam. The project for restoring the migration possibility became possible through financial support of the EU INTERREG BSR programme project "Development, promotion and sustainable management of the Baltic Sea Region as a coastal fishing tourism destination" (RETROUT).

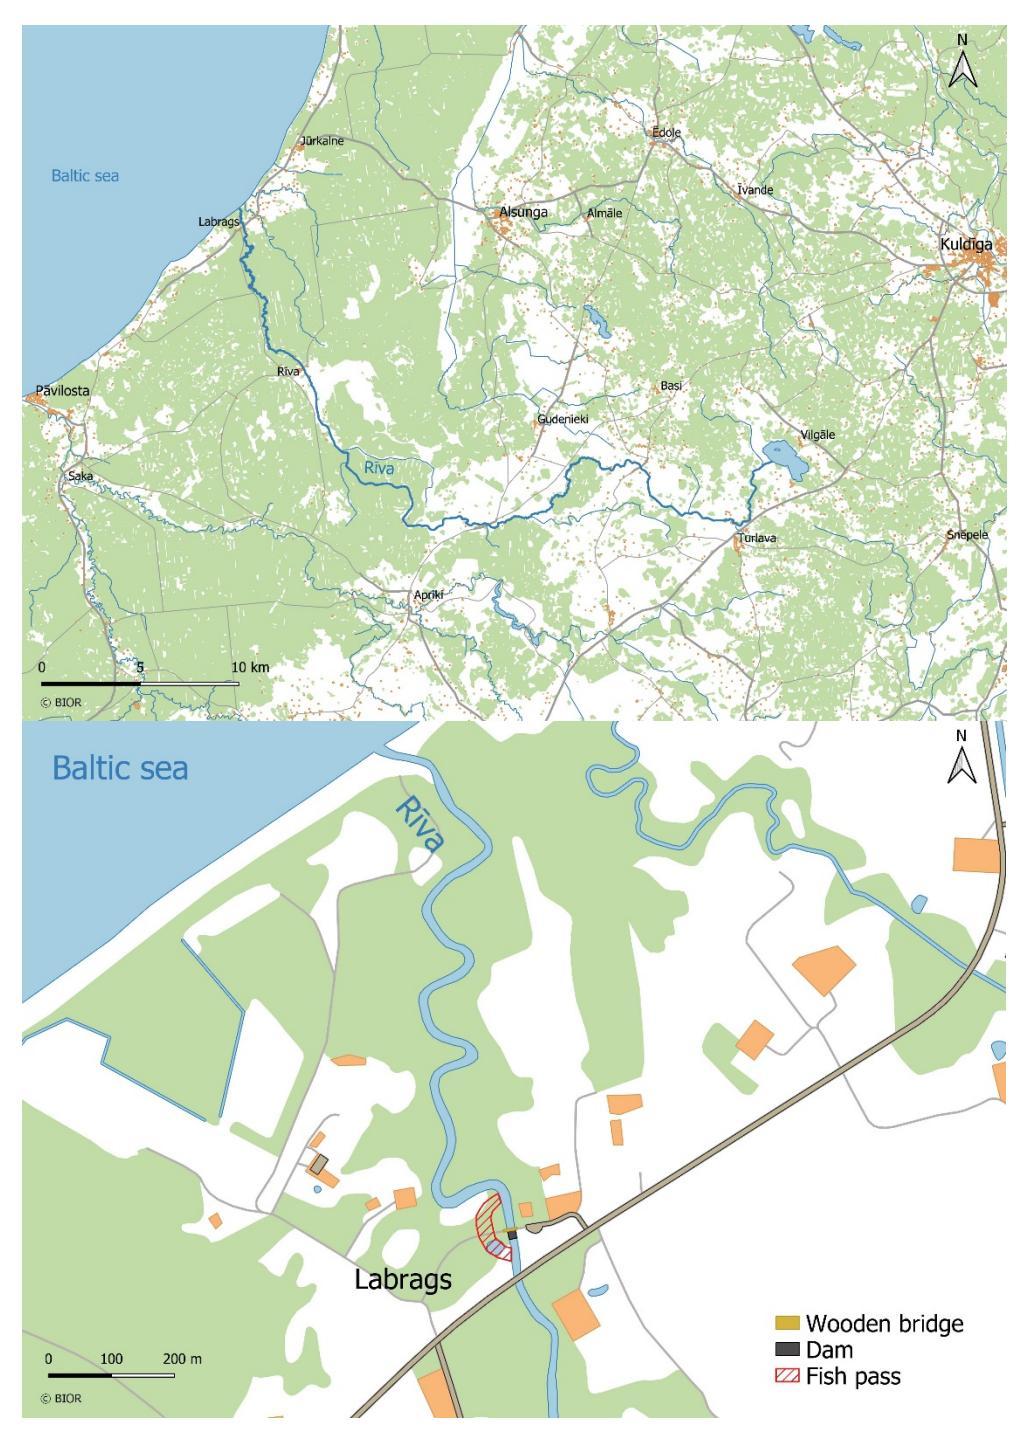
Figure 20–21. Overview and detailed location of the Rīva river restoration site.

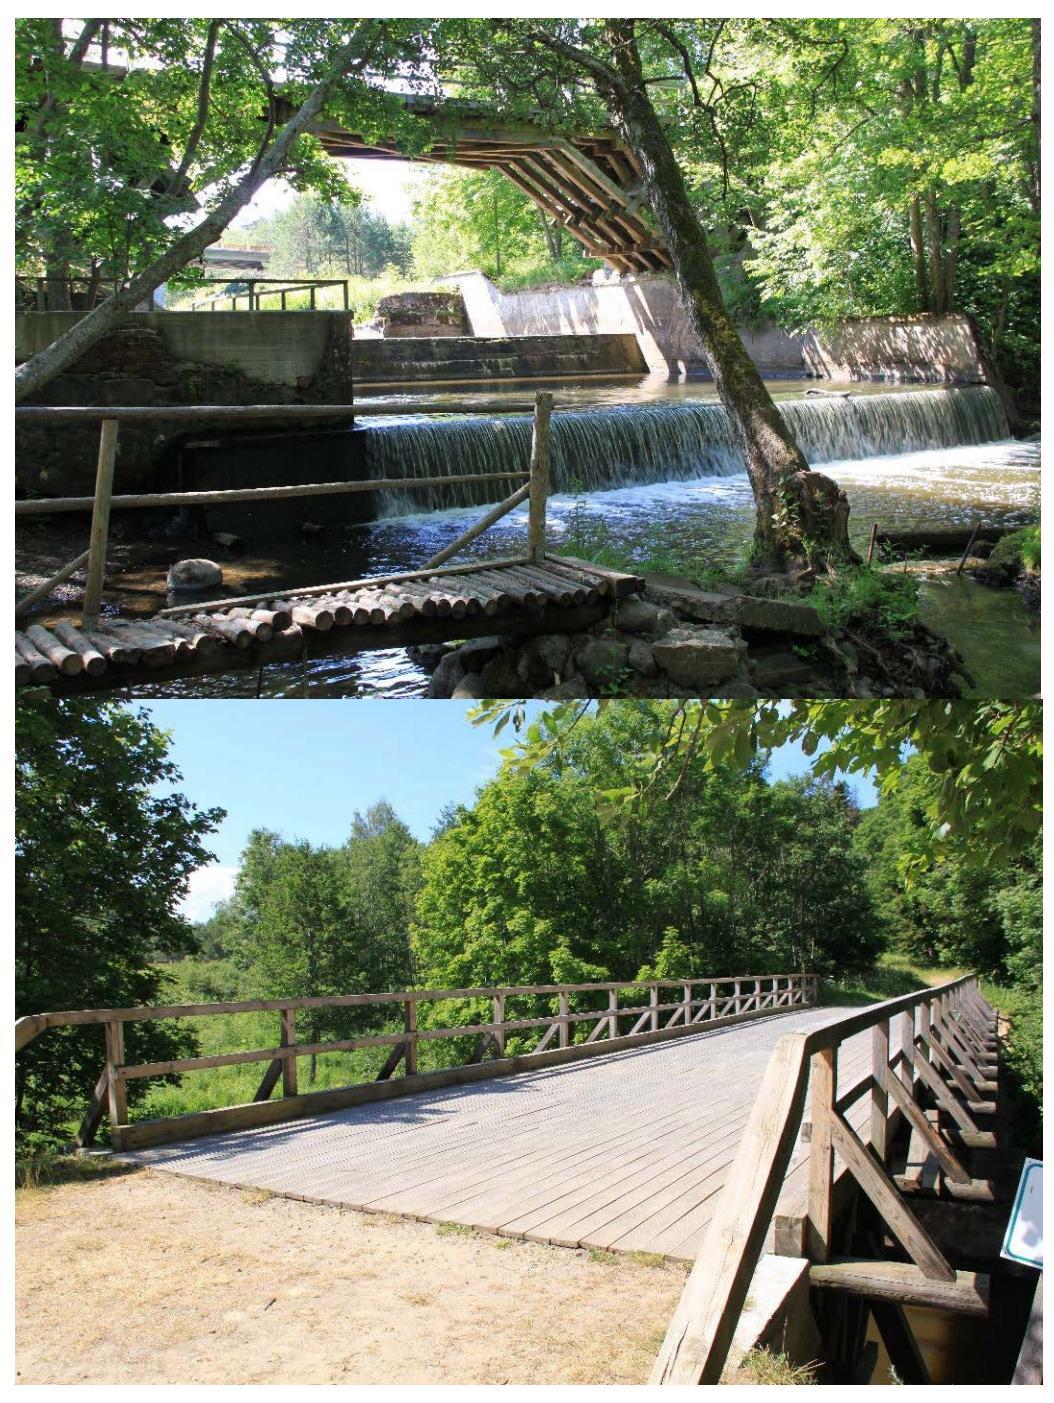
Figure 22. Pictures of the restoration site in Rīva river, with the artificial waterfall and the wooden bridge. Photo credit: Ventspils county municipality.

The restoration activity was not directly aimed towards provision of additional recreational objectives, yet it is likely that the fish pass itself will add some value to the site. The bridge over Rīva river is a replica of a wooden bridge which was included in list of national scale culture monuments. The bridge and to some extent also the ruins of unfinished paper mill and the dam itself is a popular tourism object. During planning and designing of fish pass great attention was paid to retain the value of site as much as possible, which was achieved. The fish pass will not have noteworthy impact on the bridge, ruins and dam. As it was insisted by the local landowner and other stakeholders, the remains of the dam will continue to function as an artificial waterfall. Special activities for monitoring the attractivity of the site for tourists is not planned.

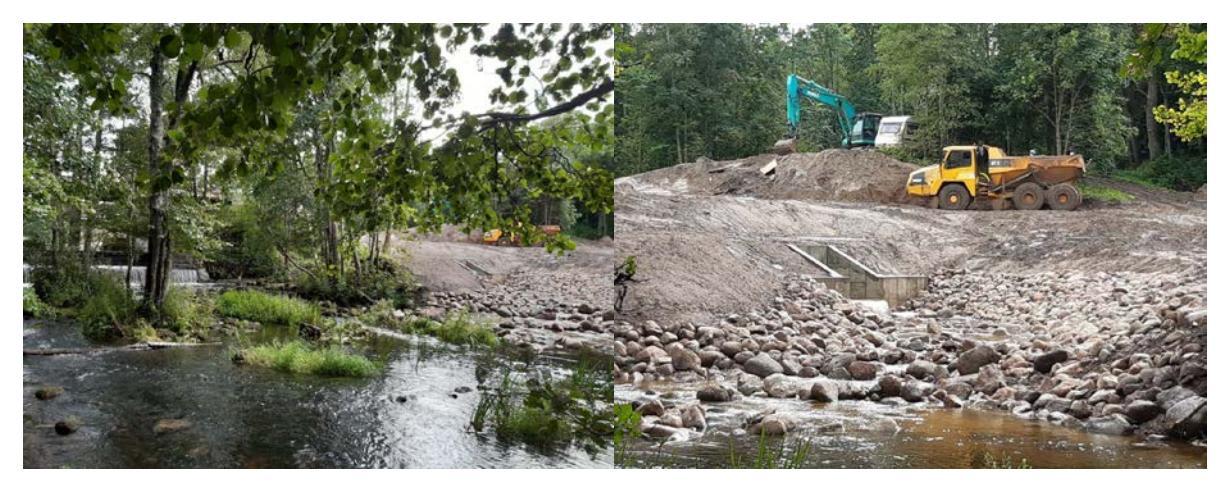
Figure 23. The fish pass site during construction in August 2020. Photo credit: Kaspars Abersons.

As the planned budget for building work was much smaller than the contracted sum that was chosen after the procurement procedure, a challenge to find lacking funds for financing the project emerged. Also, additional payments for construction and author supervision services were required. The state policy stipulates that the Treasury loan can be received only to cover the eligible costs of the project, and that was not enough to cover the difference between the planned and realised costs. A solution was found when the RETROUT partnership reallocated the project budget, enabling unused financial resources of other partners to be directed to cover the construction costs of the Rīva river fish pass. By this, the municipality received an opportunity to request an additional loan from the Treasury. It is also important to emphasize the municipality's efforts to find and use financing from various sources, e.g., funds from the municipal fish fund budget were utilised to pre-finance construction costs. The construction work on the site started in June 2020 and was completed in September 2020 (Figure 23).

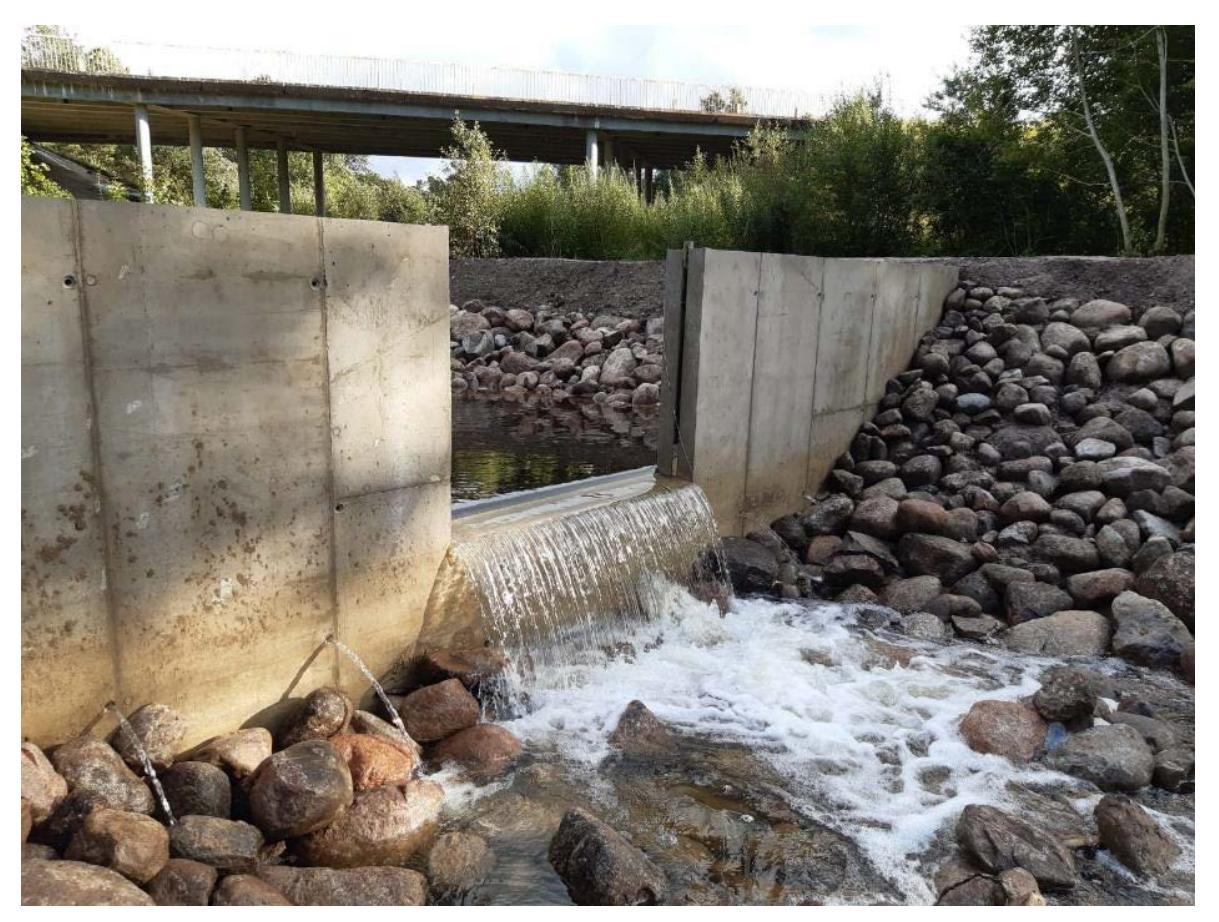
Figure 24. The fish pass site after construction in September 2020 (Photo credit: Kaspars Abersons).

Regular meetings were held between the involved parties to control the building process and the issues connected to that. In the final stage of the construction works there were concerns brought up regarding the functionality of the fish pass during low flow conditions (Figure 24), based on some received information on potential discrepancy between the design and the realised construction. Information was received from locals that there was a risk that the fish pass would only work at high flow conditions. It was agreed that BIOR will investigate this issue further, and consecutively keep the restoration project group as well as RETROUT WP4 lead and lead coordinator informed.

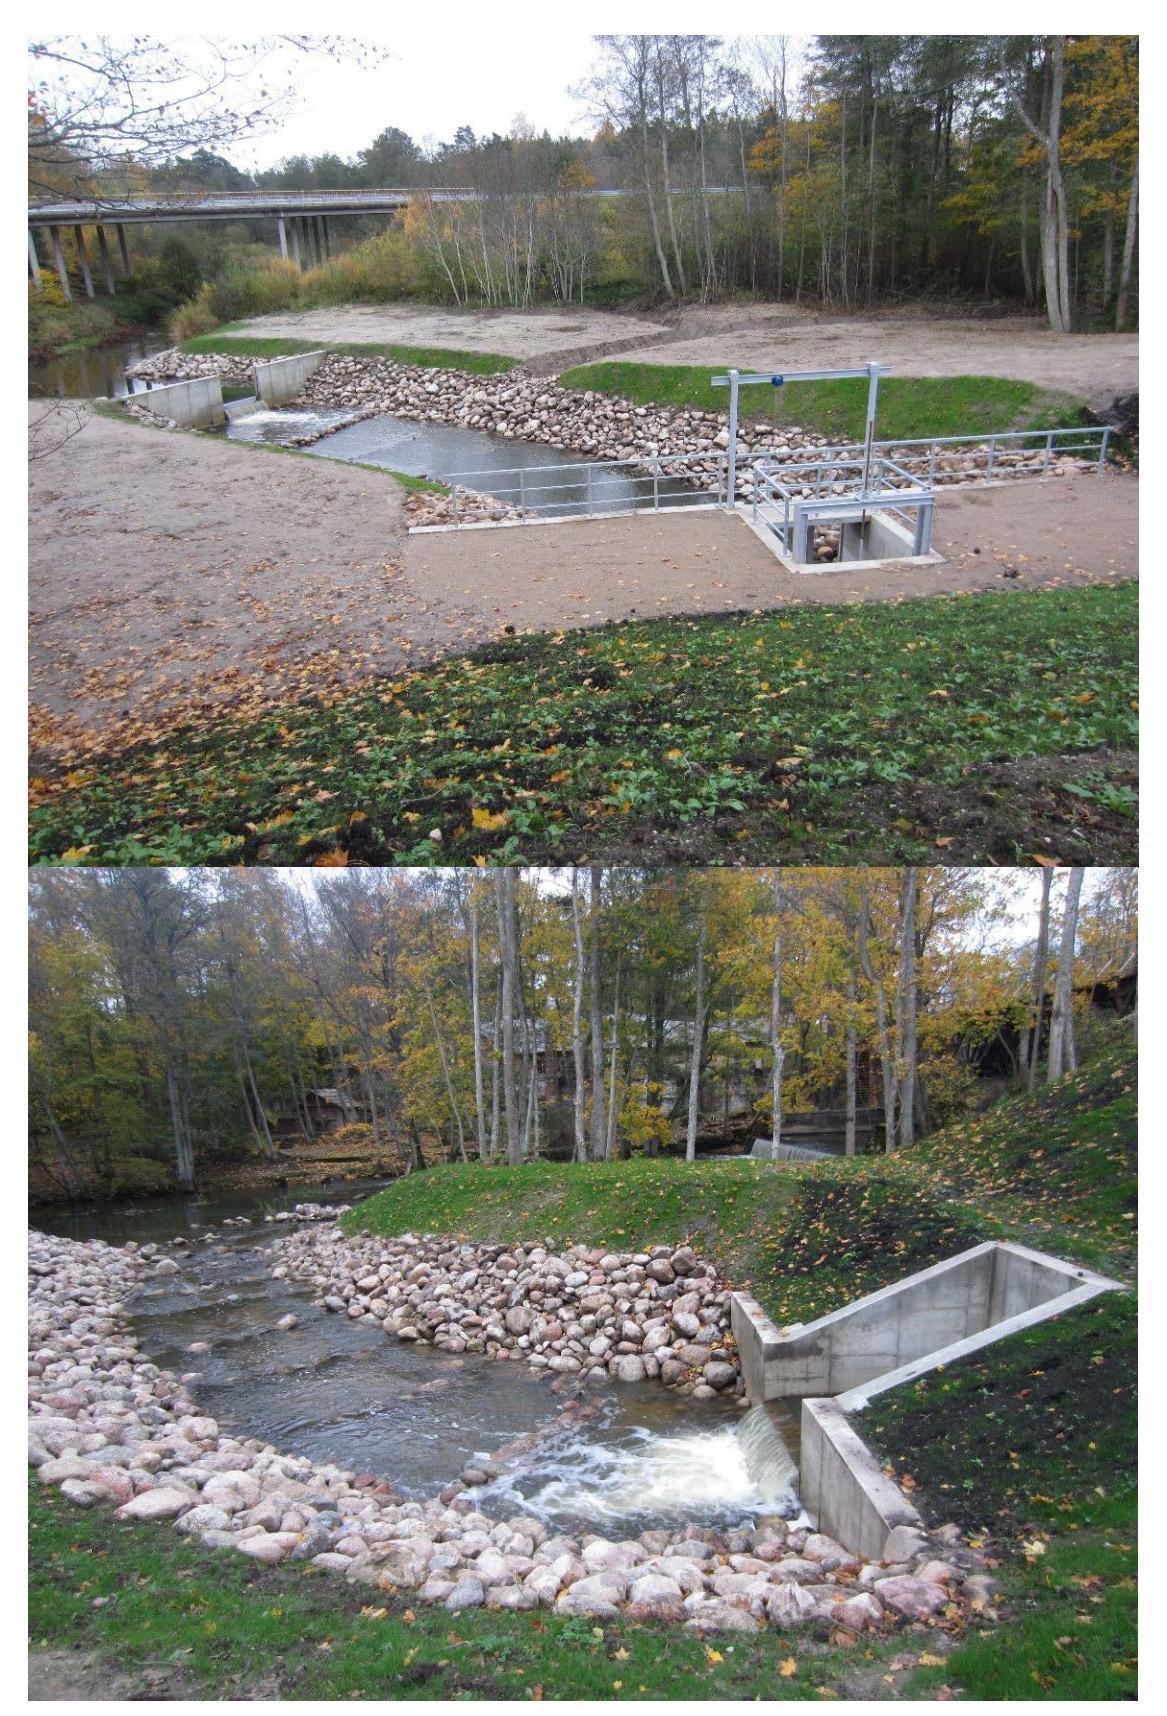
Figure 25. The fish pass site after construction in October 2020. Photo credit: Ventspils county municipality.

During further investigation it was made clear that the received alarmed signals from several parties about what is happening in the Rīva river were correct (Figure 25). So far, it had been announced with great confidence that the first natural fish pass in Latvia was being built in the Rīva river and it was to be suitable not only for sea trout but also for other fish and invertebrates. However, at this point the fish pass did not meet those expectations. It was found out that partly due to a faulty design and partly due to faulty construction work, the new fish pass had severe problems, inter alia in form of three new obstacles effectively obstructing fish migration. Also, 200 mm pipes had been laid in the channel controversially to aid fish migration. During low water conditions, there was extremely little water in the channel for the fish. It became clear that the design of fish pass in the late stage of the planning process had been changed without involvement or consultation of BIOR and RETROUT partners. The emerged concerns were expressed, and the involved parties started to search for a solution. Two meetings in the river side were held. A situation explanation and pictures were also sent to RETROUT project experts Martin Kesler (Estonia) and Robertas Staponkus (Lithuania), who also participated in a

On 9th October 2020 a meeting was held with all Latvian restoration project partners, designers of the fish pass, constructors and local stakeholders. After long discussions, practical checking and measurements on the spot, a compromise solution that satisfied both scientists and local stakeholders was found. It was decided that the designers make the corrections in the design of the fish pass to ensure migration possibilities for different kinds of fish and at the same time secure enough water for the main channel to retain the artificial waterfall as a tourism attraction. Openings were to be made in both of the most crucial new obstacles. The dimensions of the openings were calculated so that the bottom of the opening was 10 cm lower than the bottom of pipe in the uppermost obstacle in the main river. And the width of the opening was calculated so that during the low flow the fish pass will consume approximately one half of the flow and other half will be left for the waterfall in the main river. In addition, parties agreed that the stone piles in the fish pass will be left unchanged and the upstream parts of the pipes in the stone piles will be clogged with smaller stones. The wooden shields in the uppermost part of the culvert were to be removed.

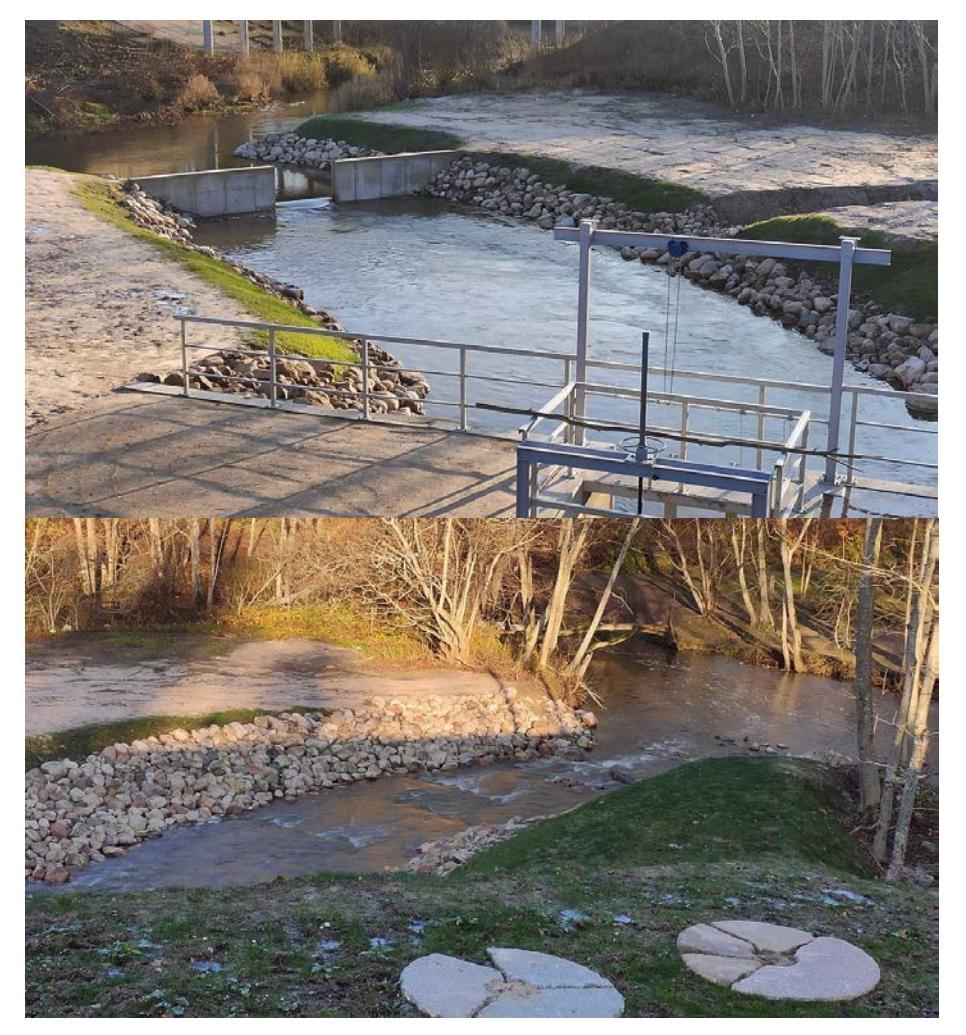
Figure 26. The fish pass during high flow conditions. Photo credit: Ventspils county municipality.

meeting at Rīva river to provide external expert consultation. It was concluded that sufficient water in the fish pass was secured only during high flows (Figure 26); in medium and low flow conditions water flow over the obstacles is poor.
